THE
TRIUMPH
MAYFLOWER
CLUB

SERVICE BULLETINS

November 2018 | Paul Burgess

Triumph Mayflower Service Bulletins

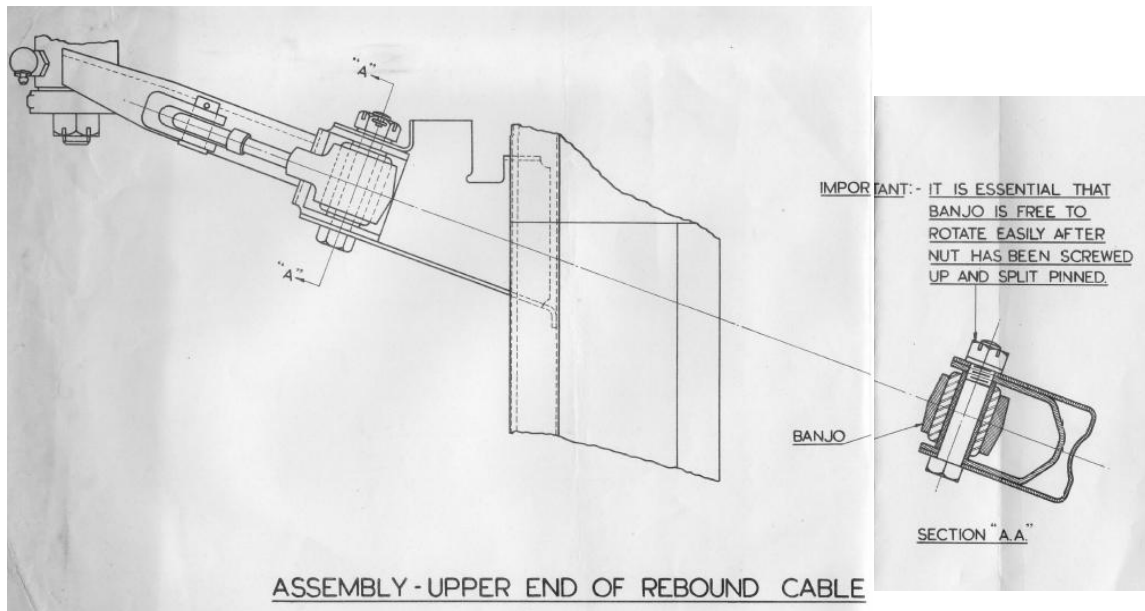
It is particularly important when carrying out Pre-Delivery Checks, or normal maintenance attentions, to Cars equipped with these cables (earlier batches were not so equipped), not to overtighten the bolt shown in Section "AA" in the attached illustration.

Failure to allow free movement of the banjo adaptor at the upper end of these cables, can quite easily cause collapse of the cables concerned.

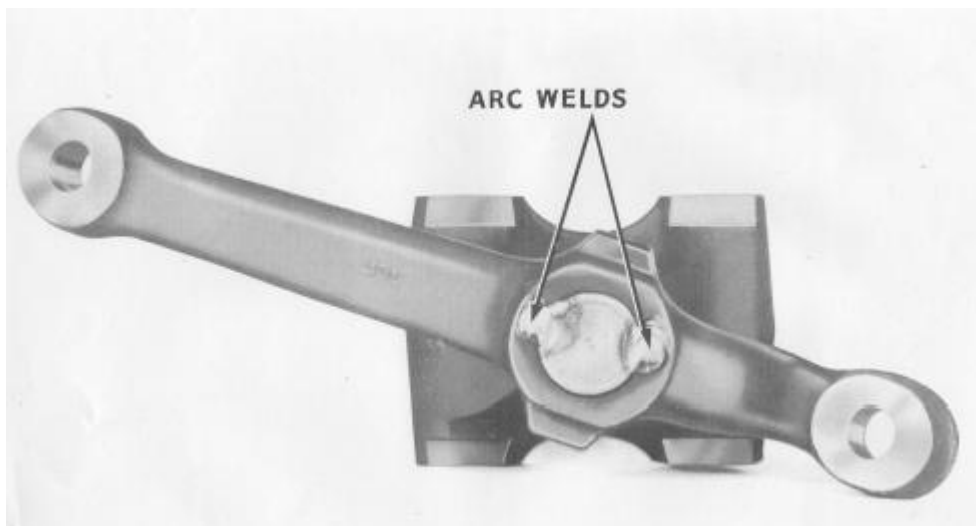
A few instances have been reported, where, owing to an unusual association of machining limits, the pin fit in the lever is insufficiently tight. The possibility of relative movement between these parts can, if not dealt with promptly, allow the spindle to be screwed out of its threaded socket in the bracket.

To prevent any possibility of such a trouble arising with future cars, the machining limits, used in the manufacture of these assemblies, have been suitably modified and the spindle arc welded in position, as shown in the attached illustration.

Immediate arrangements should be made to examine all Cars of this type, prior to the Commission Number quoted at the end of this Bulletin.

Any movement between the spindle and the lever can easily be detected by placing the thumb and finger on the parts concerned whilst the steering is moved against the weight of the Car. Where any movement between the lever and spindle is occurring, a replacement Drop Arm Assembly, Detail No. 20013U should be fitted.

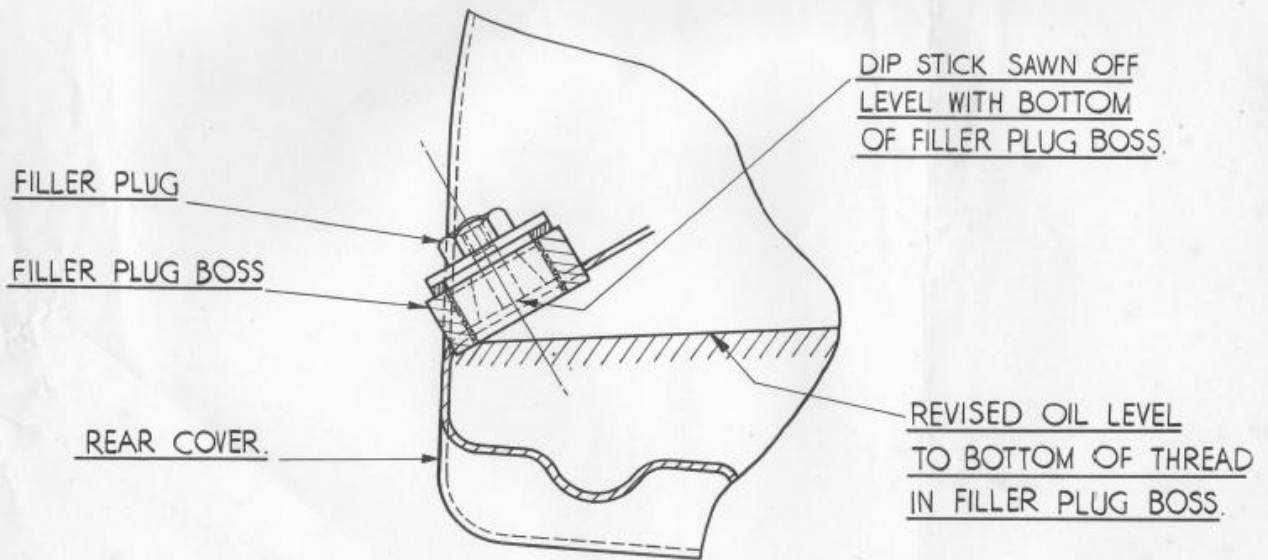
DESCRIPTION.
REVISED REAR AXLE OIL LEVEL

It has been found necessary to raise the oil level in the Rear Axle fitted to this model.

The Dipstick is to be deleted and the axle is now to be filled until the oil reaches the lowest point of the thread, into which the Filler Plug Dipstick Assembly screws. The oil should not now be allowed to fall more than 1/2" below the level shown in the sketch overleaf.

The Rear Axle Dipstick, fitted to Cars of this type should now be cut off with a hacksaw, carefully removing all swarf before refitting.

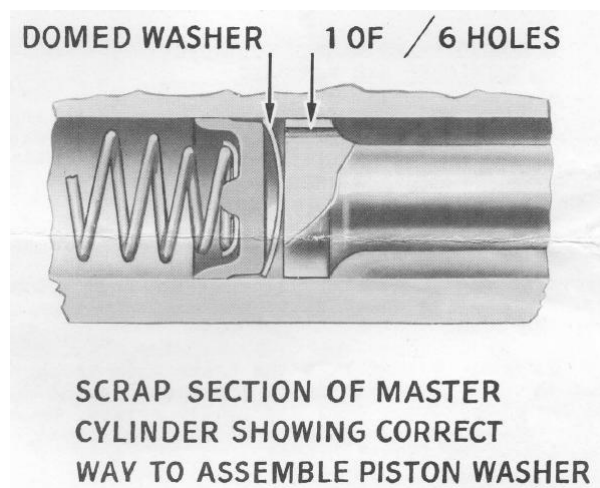
Illustration attached.

A domed and "coppered" brass shim is interposed between the piston and the main rubber cup. This domed shim is fitted with a view to preventing any possibility of portions of the rubber cup being extruded through the six small holes, in the piston head, and thus interfering with proper recuperation.

The domed shim is fitted with the convex portion towards the top of the piston, as shown in the illustration attached. Thus, when the pressure on the washer is relieved, the shim which flattens under pressure resumes its domed shape and uncovers the recuperating holes in the piston head.

It would appear that the brass shim is causing some form of chemical reaction in the Unit, since the fluid in the region of the rubber cup and shim has, where this difficulty arises, become discoloured and "tacky". To remove any possibility of chemical reaction, these brass shims will, in future, be nickel plated.

If, in cases where this trouble is experienced, the brass shim is removed, the system will operate quite satisfactorily, but the life of the rubber cup will be considerably reduced and this procedure should only be adopted as a temporary measure, where a nickel plated shim is not available.

Supplies of the nickel plated brass shim, Detail No. 103020, can be obtained from our Spares Department.

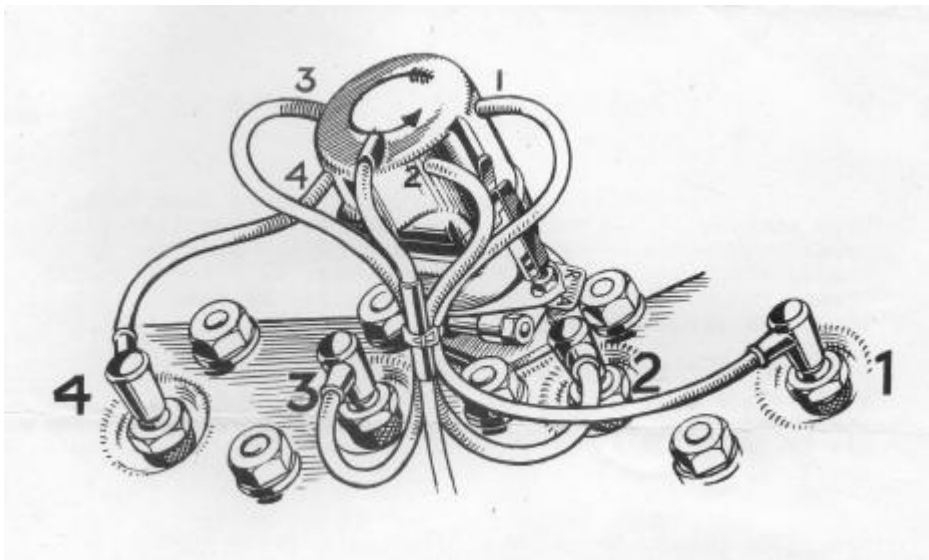
Instances have occurred, where this cable has been severed by vibration, when used in conjunction with the radio suppressor. The introduction of the sparking plug lead cleat, which was fitted to prevent Nos. 1, 2 and 3 cables making metallic contact with the engine, by restricting vibration, has prevented further fracture of this cable.

The cleat is shown fitted, in the illustration overleaf its incorporation necessitating the lengthening of the three front sparking plug leads. The new length of leads is 11.7/8", 8.1/8" and 10.3/4", respectively, for Nos. 1, 2 and 3 cylinders.

When replacing this cable, following failure, the cable cleat, detail No. 60527, should be installed together with the necessary longer leads. The cable cleat may be obtained from our Spares Department.

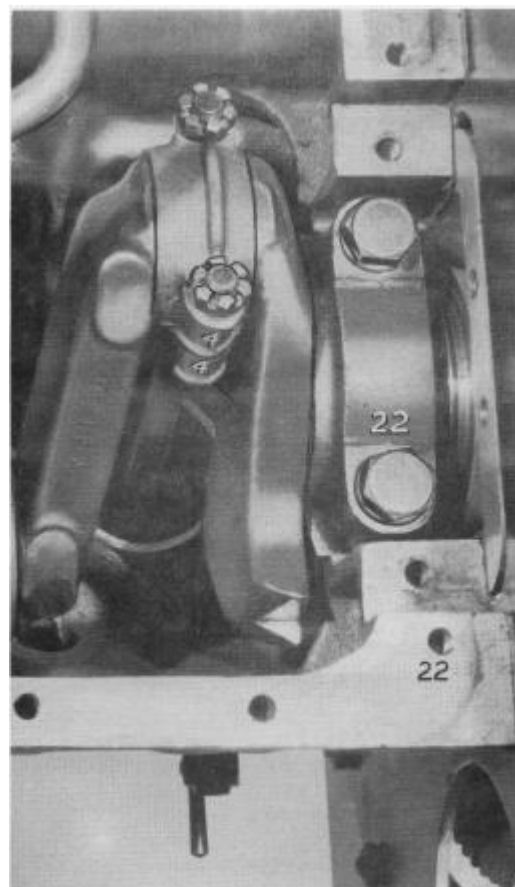
If it is found necessary, at any time to remove the main bearing caps with one of these Cars, it is imperative that these should be fitted the correct way round on reassembly. To ensure the correct location of these caps, they are marked on the right hand side, as shown in the illustration overleaf, to correspond with similar numbers punched on the crankshaft flange on the same side of the engines. The numerals used for location purposes, vary from engine to engine.

Quite apart from the fact that these bearing caps are line bored with their respective housings, during manufacture, in the case of the front and rear caps, the boltholes are offset from the centre line of their respective caps. The offsetting of the boltholes, in the case of the rear bearing cap, which accommodates the two half thrust washers, makes its correct assembly of supreme importance.

Failure to assemble these bearing caps the correct way round will not only upset the proper relation of the main bearings, but also in the case of the rear bearing cap and thrust washers, force the crankshaft and connecting rods out of their proper alignment in the engine and possibly cause serious damage.

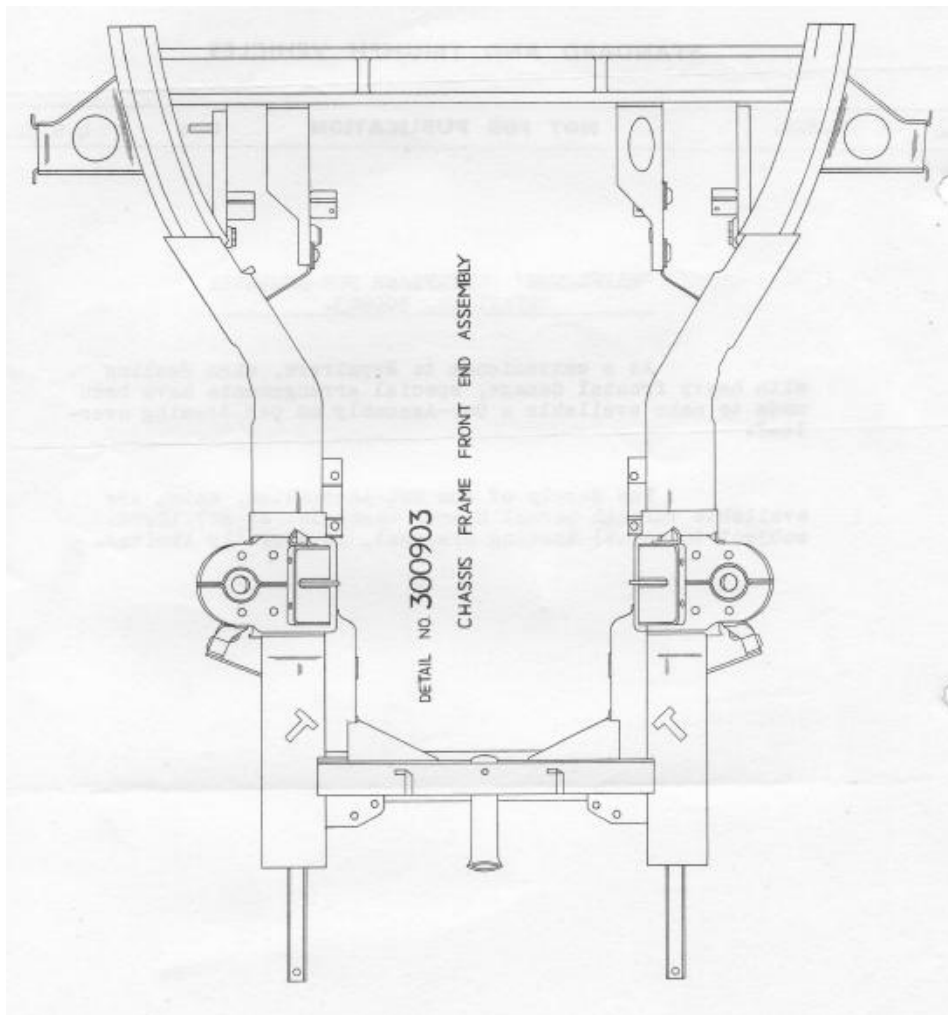
As a convenience to Repairers, when dealing with heavy frontal damage, special arrangements have been made to make available a sub-assembly as per drawing overleaf.

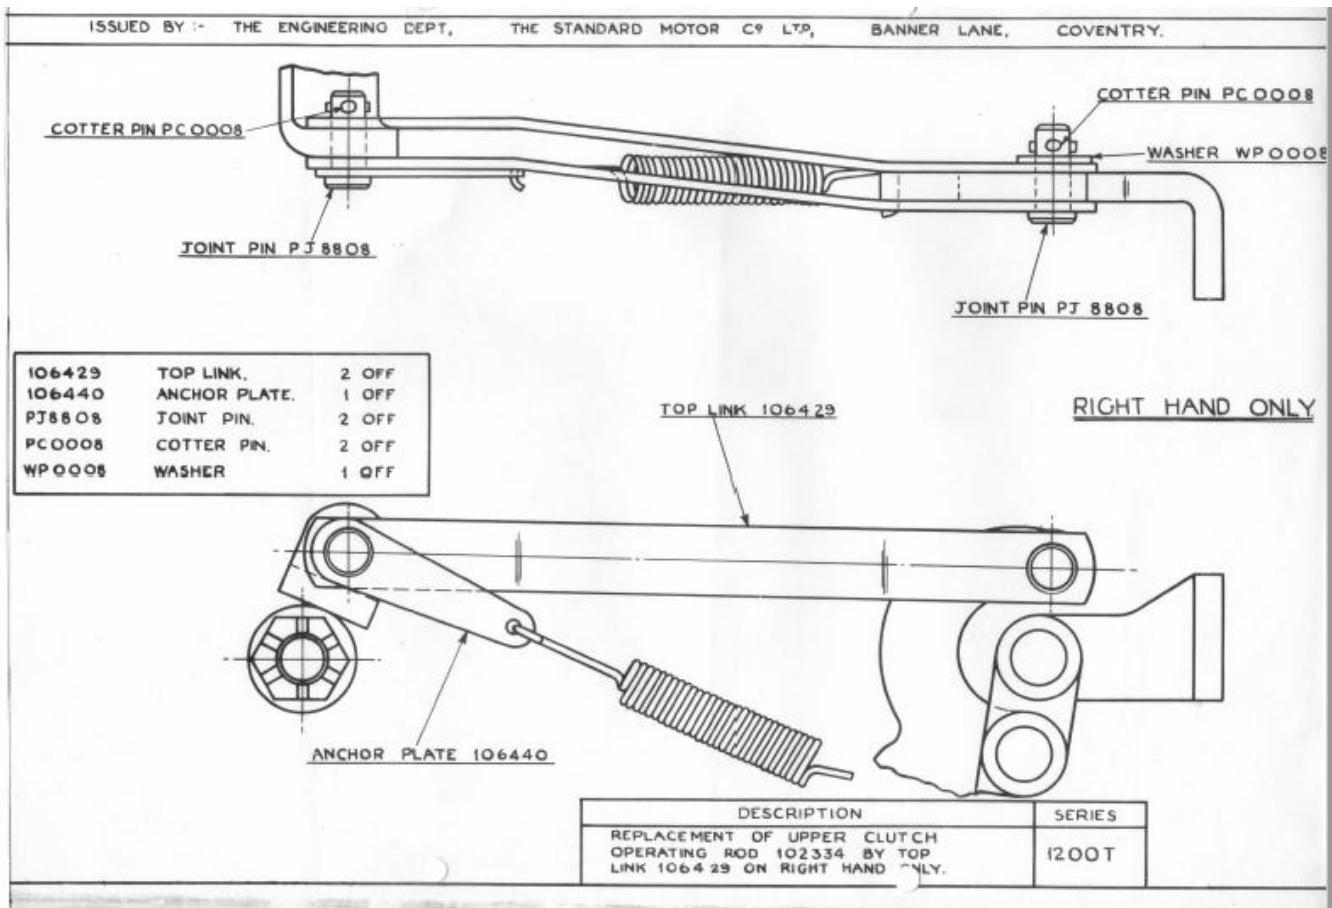
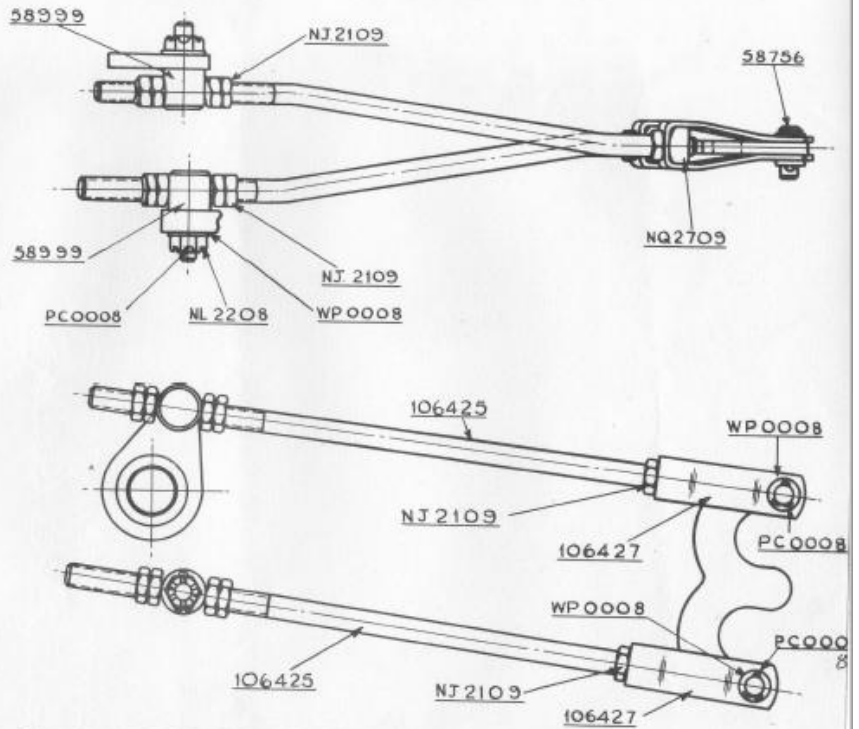
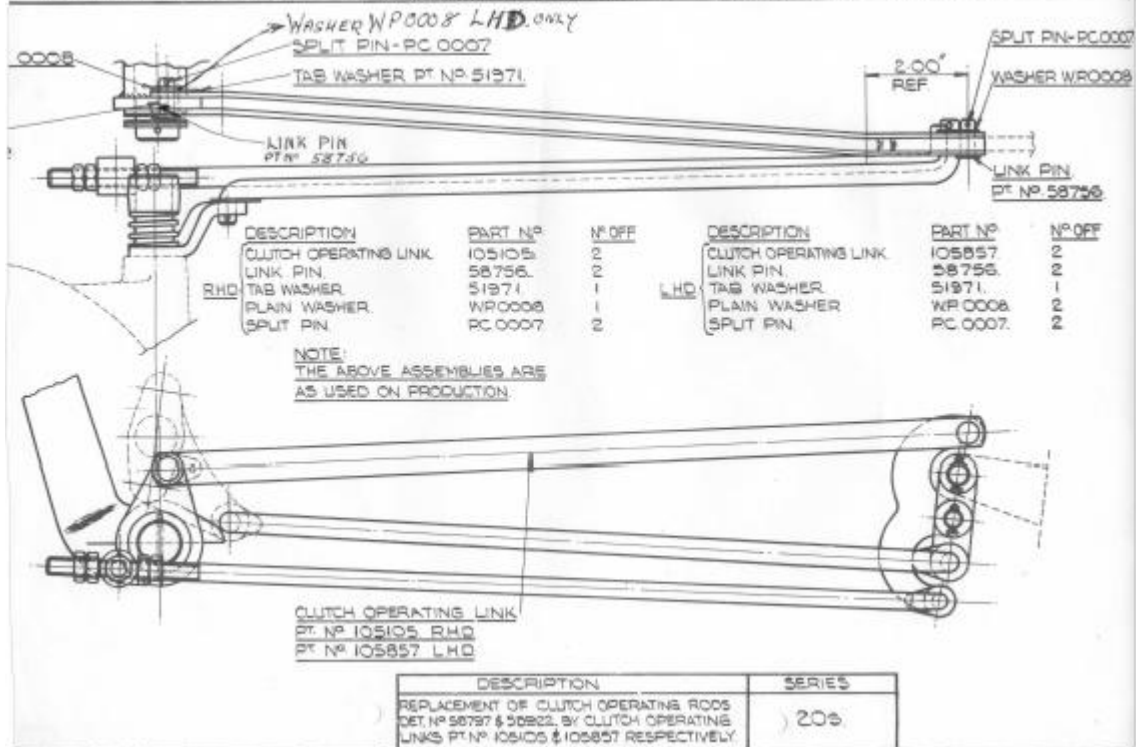
DESCRIPTION.	SERIES
REPLACEMENT OF CLUTCH OPERATING RODS 101106 & 101111 BY CLUTCH OPERATING ROD 106427 - 2 OFF.	20ST.

Since manufacture of these models commenced a modification has been introduced in connection with the Top Clutch Operating Rod. This alteration was made with a view to eliminating the sharp bends at each end of the rod, which were previously used. These rods have proved susceptible to fatigue fracture, where large mileages, or exacting conditions of clutch operation, are involved.

Repairers are recommended to make this modification when fitting a new clutch assembly, as the installation of such a unit is likely to precipitate a failure of a fatigue nature.

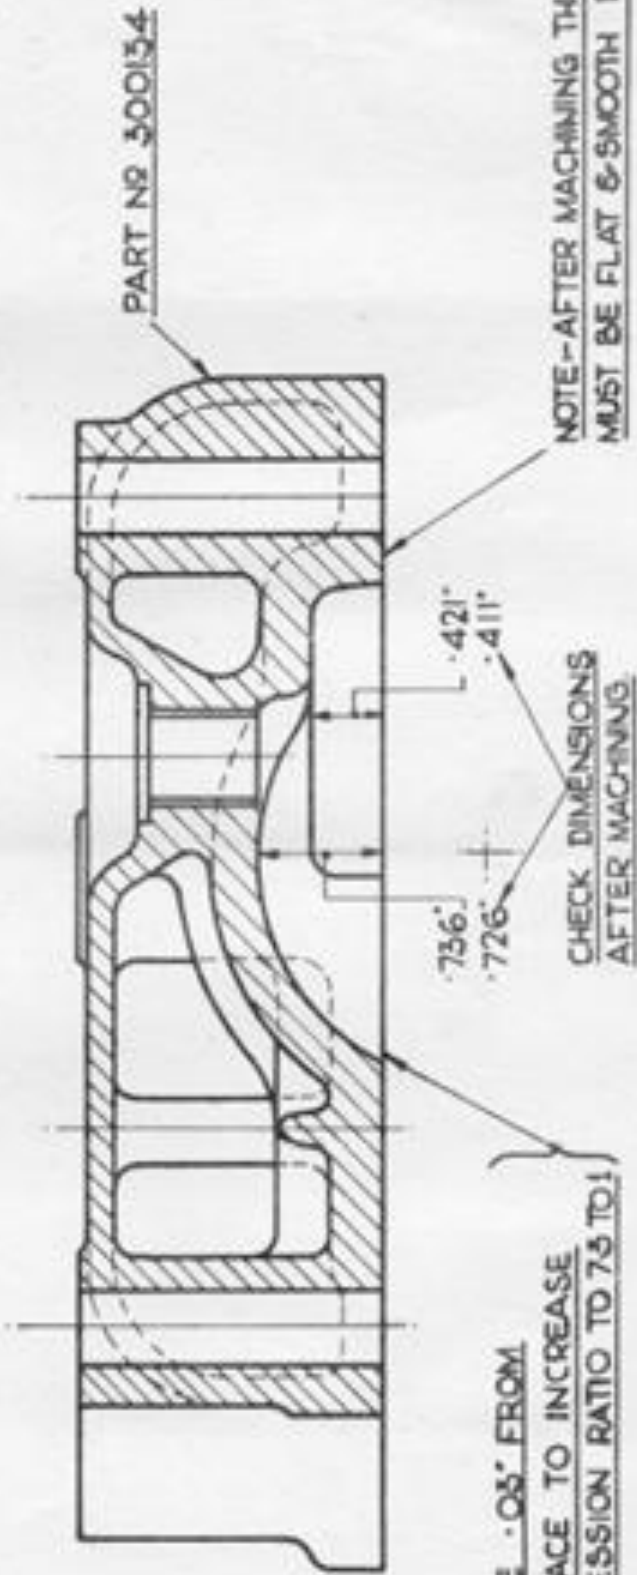
REMOVE .03" FROM
JOINT FACE TO INCREASE
COMPRESSION RATIO TO 7.5 TO 1

NOTE - AFTER MACHINING THIS SURFACE
MUST BE FLAT & SMOOTH FINISH.

It is not proposed, at the present time, to introduce any replacement exchange scheme for the supply of modified compression ratio cylinder heads and the work on these heads will have to be carried out under local arrangements.

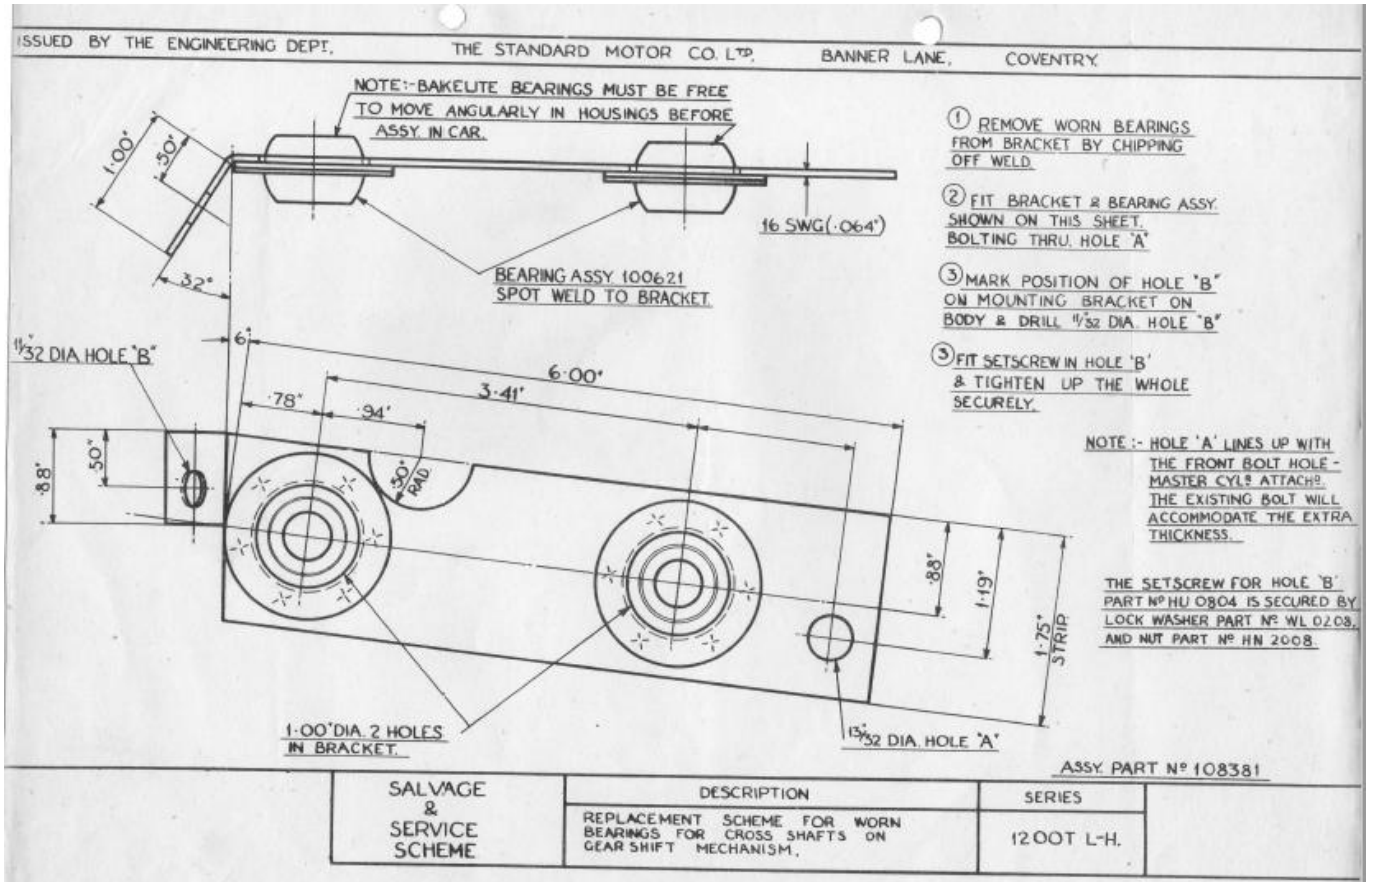
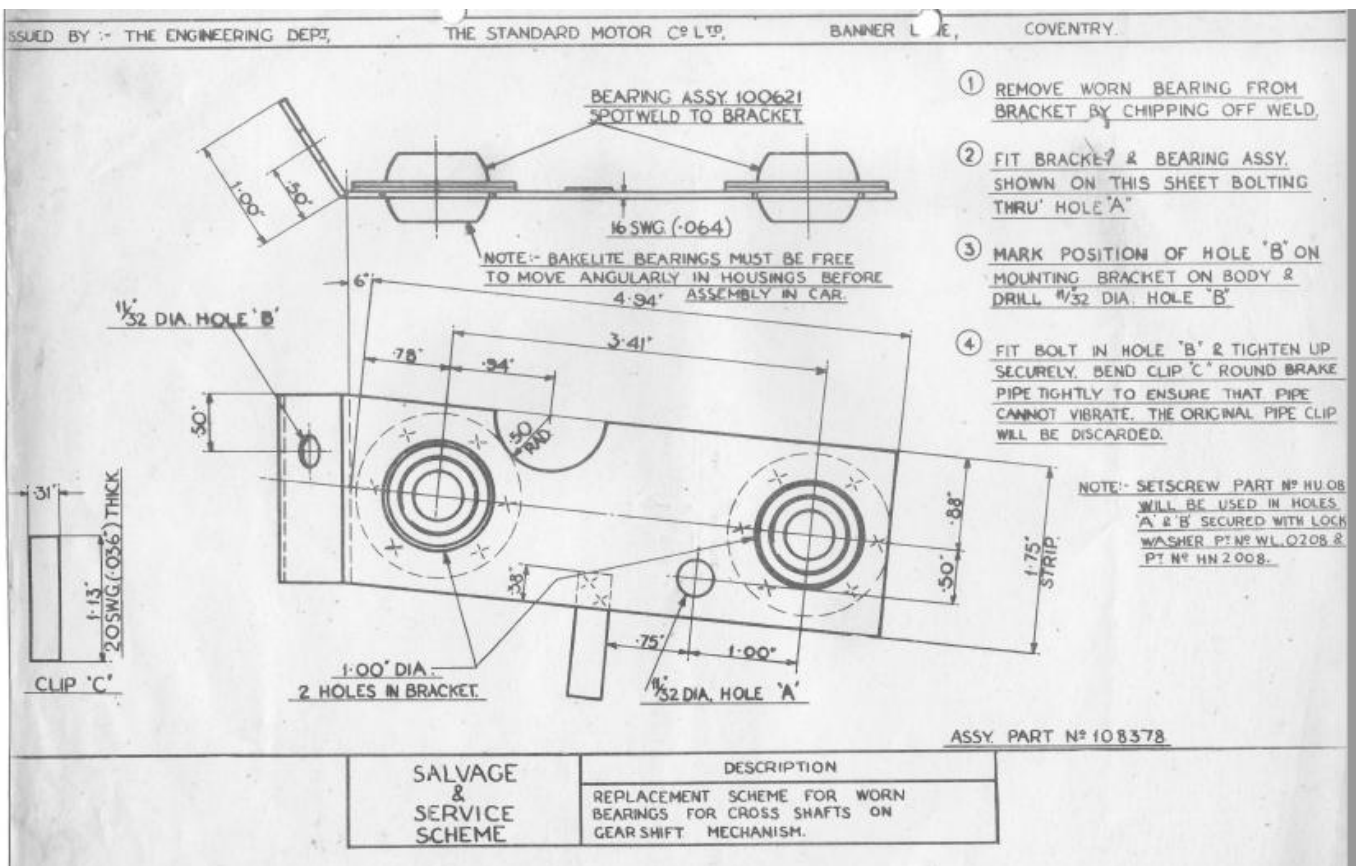
The replacement of gear change cross-shaft bearings on these Models is a straight forward operation, as the plastic bearings are mounted in a bracket which is readily detachable from the chassis.

There are two alternative methods possible, when dealing with worn cross-shaft bearings fitted to these Models. The first being to replace the existing assembly Part No. 58269 as a unit, the alternative method being to replace the plastic bearings. Part No. 38282, after separating the two halves of the bracket.

It is particularly important, in order to avoid subsequent chipping of the bearing bores, that the bearings should be free to move angularly, after the two halves of the bracket have been riveted together, and if necessary shims should be fitted between the two halves of the assembly to provide this freedom of movement. Snap Head rivets 1/8" by 1/4", Part No. SP 91 B2 are those specified for riveting these brackets.

Where replacements have to be fitted, the existing bearings and their housings should be removed and replaced by the assemblies, as explained in the attached Service Schemes.

In cases where there is an urgent need for fitting replacements, sufficient details are given in the Service Schemes to enable self manufacture of the brackets, whilst the bearings, Part No. 100621, are readily available from our Spares Department. To meet such cases the necessary bolts, etc, will, no doubt, be available from local sources.
