THE
TRIUMPH
MAYFLOWER
CLUB

MAYFLOWER OVERHAUL, RECONDITION, MAINTAIN

March 2018 | Paul Burgess

Overhauling the Triumph Mayflower

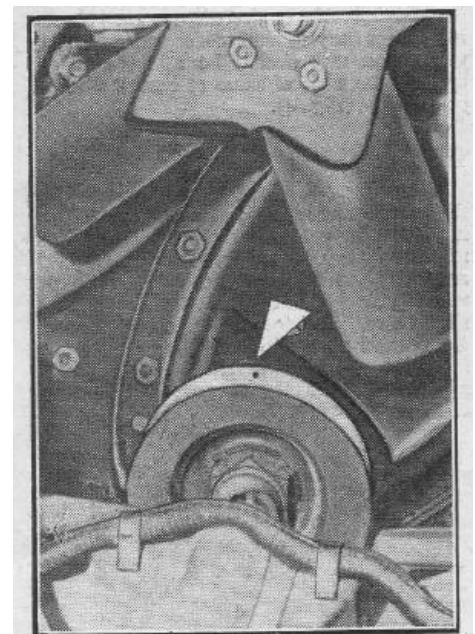
Fig. 1.—T.D.C. of Nos. 1 and 4 pistons

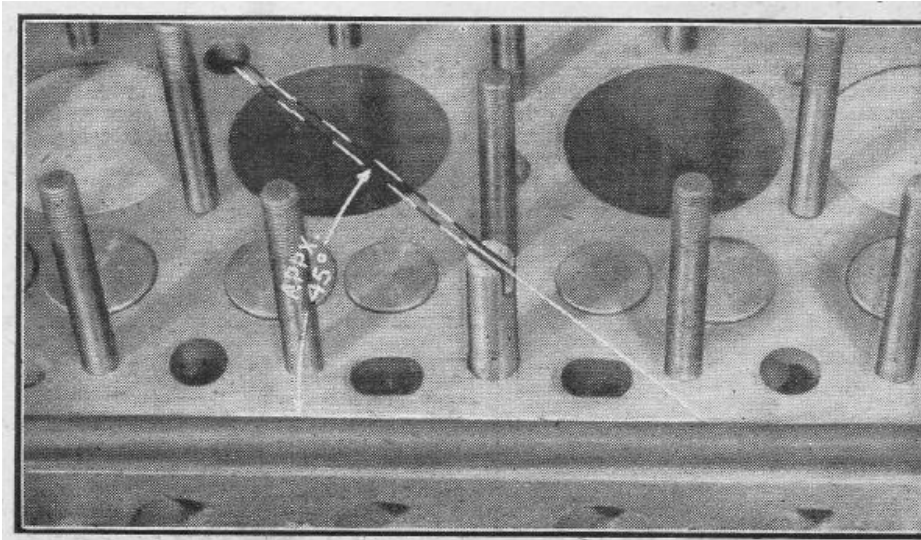
Fig. 2.—Position of offset and slot at upper end of distributor driver shaft with No. 1. cylinder at firing point.

Where the distributor oil pump helical gears are disengaged for any reason it is merely a question of reengaging by trial and error (with the engine on T.D.C. of No. 1's compression stroke) until the offset slot at the upper end of the drive shaft assumes the position shown in Fig 2

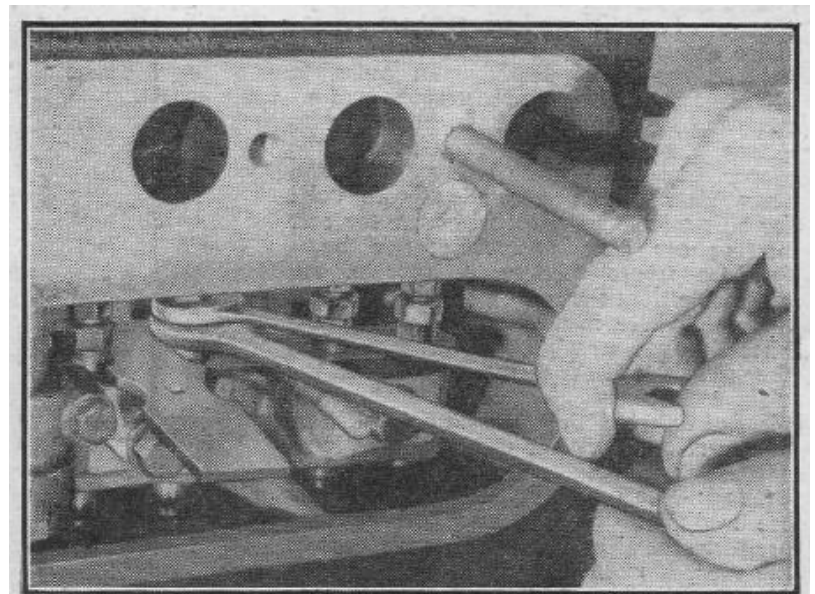
Fig. 3.—Setting tappets utilising two spanners and taper wedge.

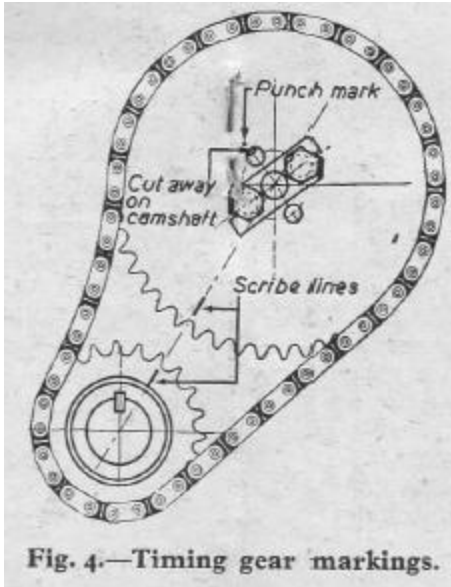
Fig. 4.—Timing gear markings.

markings shown in Fig. 4 are matched and the cut-away in camshaft is as shown. The alternative pair of set-screw holes in the camshaft gear provide a half-tooth variation in timing. Turning the camshaft gear back to front, from any position, gives a quarter-tooth adjustment, whereas the use of the second pair of holes in this reversed condition allows a three-quarter-tooth variation from the original position.

It is important when matching these markings that the driving side of the timing chain is kept tight and that neither the camshaft nor crankshaft are moved.

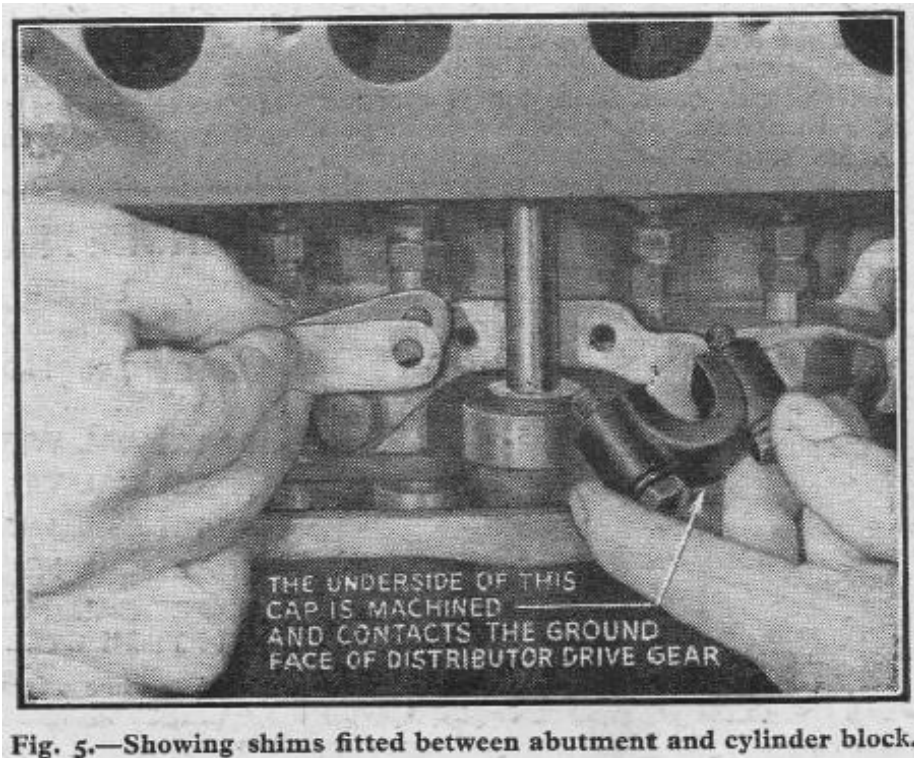
Fig. 5.—Showing shims fitted between abutment and cylinder block.

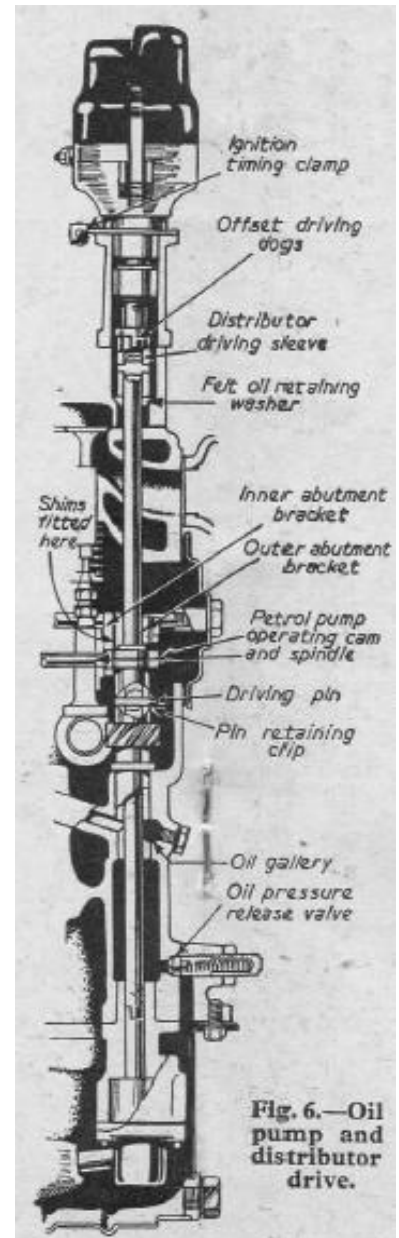
Fig. 6.—Oil pump and distributor drive.

The pump is of the double-rotor type and provides much more oil than is actually required, and little wear is likely to be experienced during the normal life of the car.

The only possible attention, apart from collapse due to a defective part, which is not likely until some 200,000 miles have been covered, will be the elimination of end float in the rotors. This can be met by lapping the joint faces on the rotor casing and cover assembly.

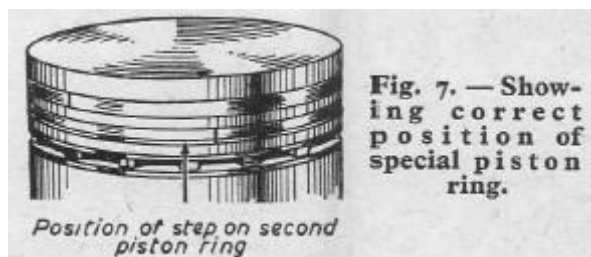
Two compression rings are fitted, the lower one of these being tapered (see Fig.7). The tapered ring must be fitted with the larger diameter downwards. The correct fitting position is identified by the etching of a "T" on the upper face of the ring. The compression rings fitted to a very few early cars were of the parallel type.

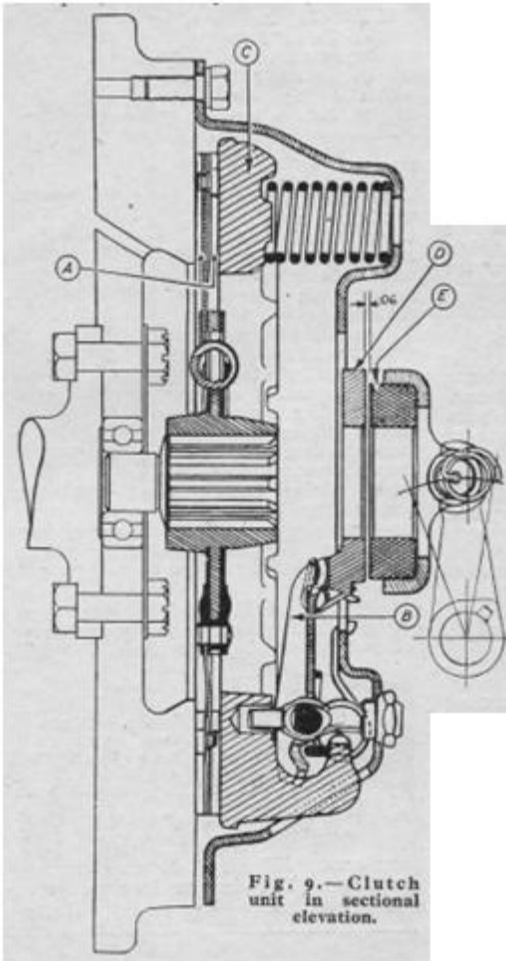
Fig. 9.—Clutch unit in sectional elevation.

As wear occurs to the friction facings (A), the outer ends of the release levers (B) will move with the pressure plate (C) closer to the flywheel, and the inner ends of these levers will move outwards with the release lever plate (D) thus reducing the clearance between (D) and (E). It will be understood, therefore, that as this necessary clearance of 1/16in. (.0625in.) is reduced by wear it is necessary to restore it by suitable adjustment of the fork which carries the release bearing carrier. This is effected by alteration of the adjusting nuts shown in Fig. 10.

After exchange of the centre plate, which does not require any alteration to the clutch cover assembly, nor, indeed, must such be attempted, it is merely necessary to adjust the four nuts shown in Fig. 10, until there is an inch of free movement at the pedal pad, which represents the necessary 1/16in. clearance between (D) and (E) (see Fig. 9).

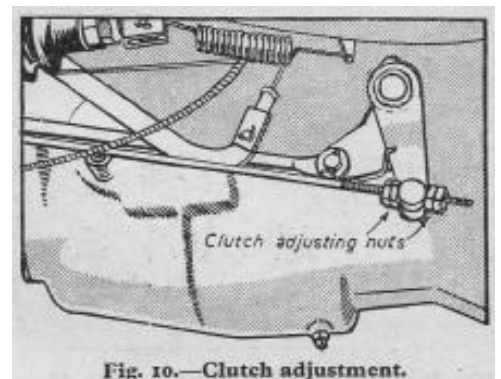
Fig. 10.—Clutch adjustment.

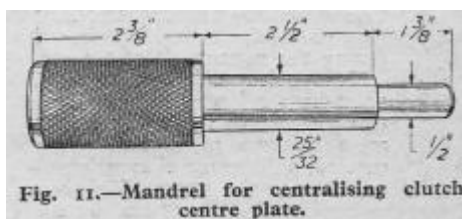
to the cover assembly when withdrawing the unit, it will be necessary to centralise it before offering up the gearbox with a suitable mandrel. Fig. 11 gives the dimensions of a suitable mandrel. A mandrel can be made less elaborately from wood, provided the two smaller diameters are as given, to fit into the splined centre of the clutch and the bush in the end of the crankshaft.

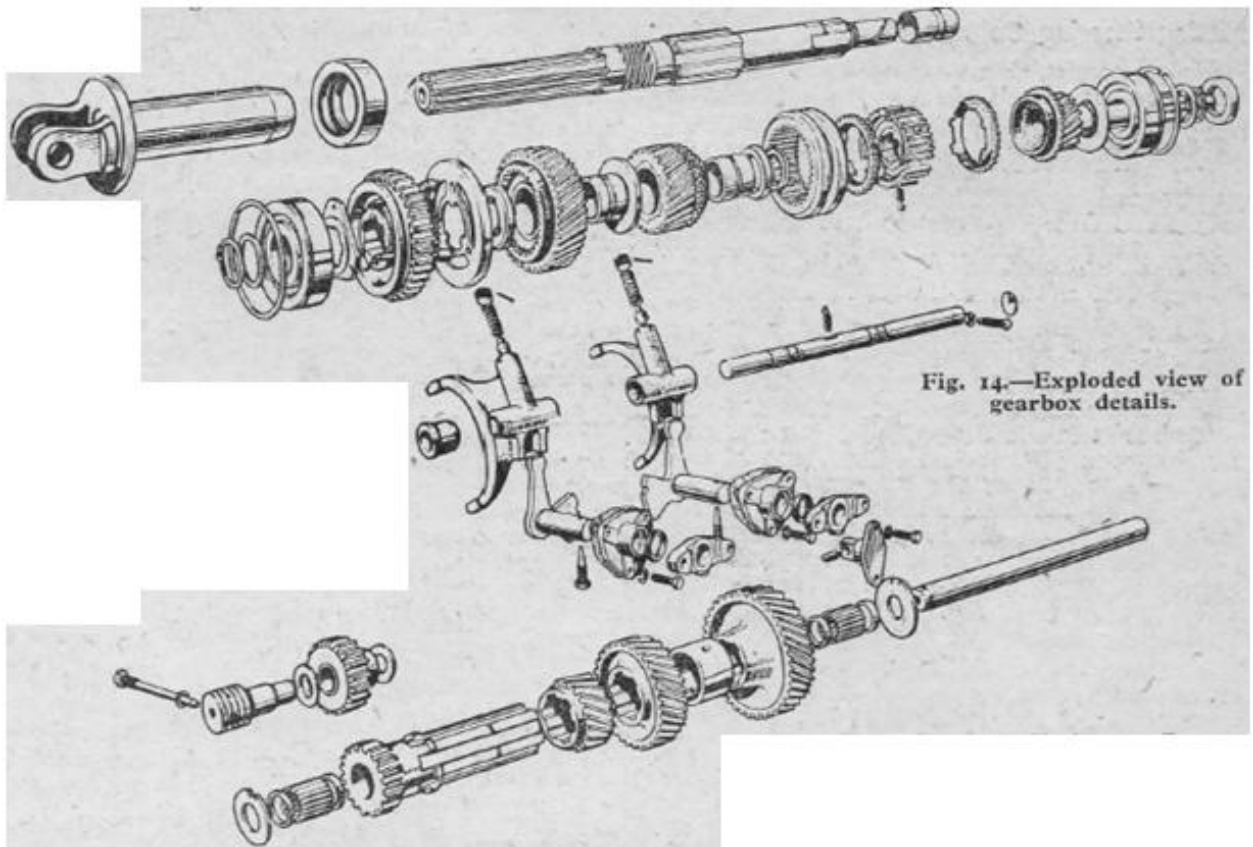
Fig. 14.—Exploded view of gearbox details.

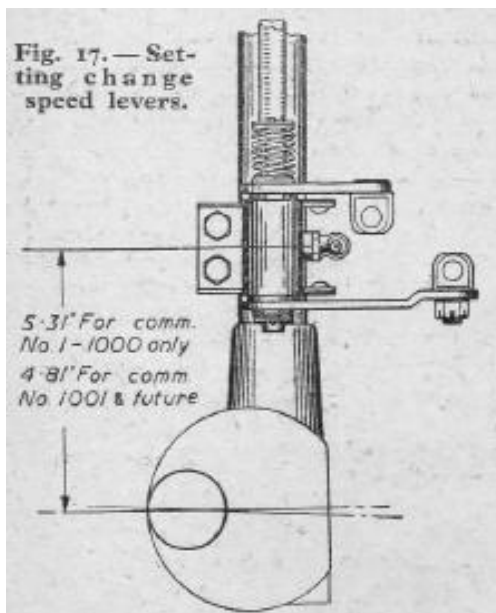
will go, the upper side of the knob is approximately 1 3/8in. from the underside of the steering wheel, as shown in Fig. 17. Secure this bracket in this position.

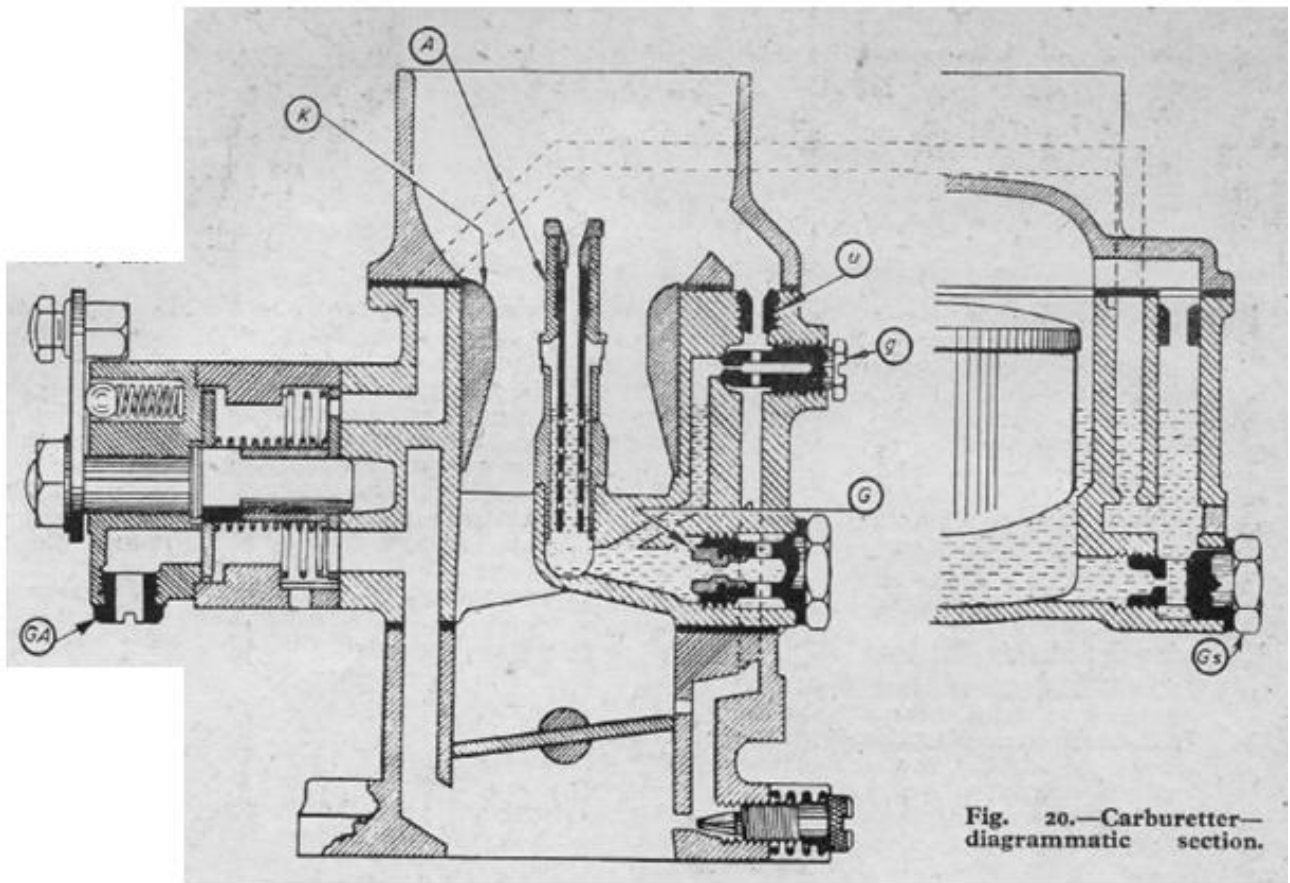
Fig. 20.—Carburetter—
diagrammatic section.

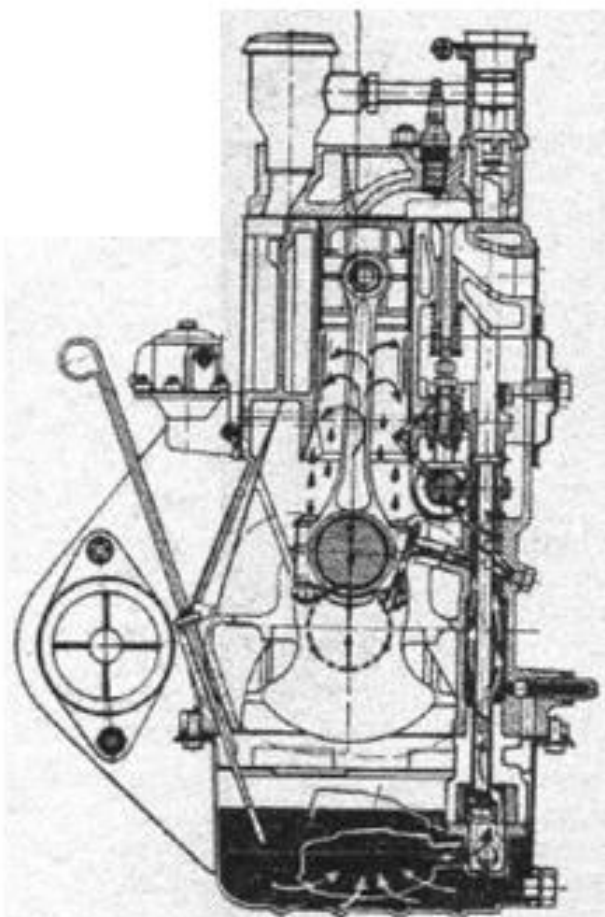
Fig. 1.—Cross-section of Mayflower engine showing lubrication system.

Fig.1 shows a cross-section of the engine with

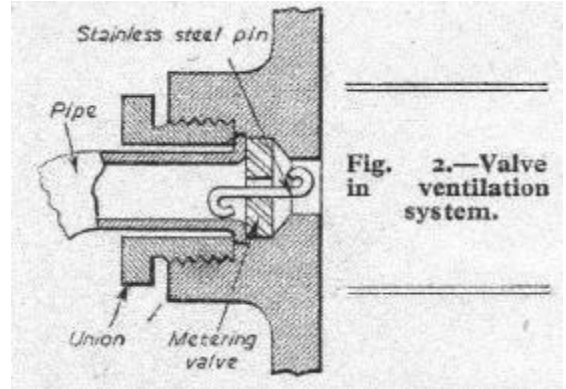
Fig. 2.—Valve in ventilation system.

Crankcase ventilation is accomplished on the sealed engine principle, in which a depression is created in the crankcase through a pipe connected to the induction manifold. The important features of this system are engine joints must be sound to remain sealed; the metering valve (Fig. 2) in the manifold must be kept clear of carbon for the system to function. The valve contains a stainless steel pin, and movement and vibration should maintain it free. Nevertheless, it should be examined from time to time during servicing operations, but not altered in any way. If the valve becomes choked with carbon pressure will be created in the crankcase and oil may be forced through joints or through the front seal behind the crankshaft pulley or past the rear seal in front of the flywheel—in which case oil would pass into the clutch casing, and clutch troubles might ensue.

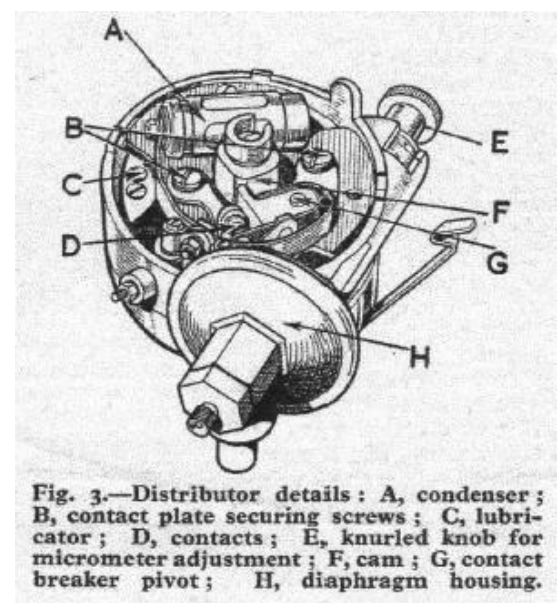
Fig. 3.—Distributor details: A, condenser; B, contact plate securing screws; C, lubricator; D, contacts; E, knurled knob for micrometer adjustment; F, cam; G, contact breaker pivot; H, diaphragm housing.

The distributor mounted on the cylinder head is driven from an offset slot at the top of the vertical shaft. The distributor can be detached complete for cleaning or when decarbonising, and the timing will not be disturbed so long as the clamp is not loosened. Fig. 3 depicts details of the distributor.

With the rotor pulled off a few drops of oil can be applied to the centre for lubrication of the cam bearing, and a trace of grease can be put on the cam, a drop of oil on the rocker pivot. Contact breaker gap should be 0.010in. to 0.012in., and the timing 2 deg. before T.D.C. fully retarded. Champion type NA.8 sparking plugs, $\frac{3}{8}$ in. reach, are recommended, set to .025in. gap.

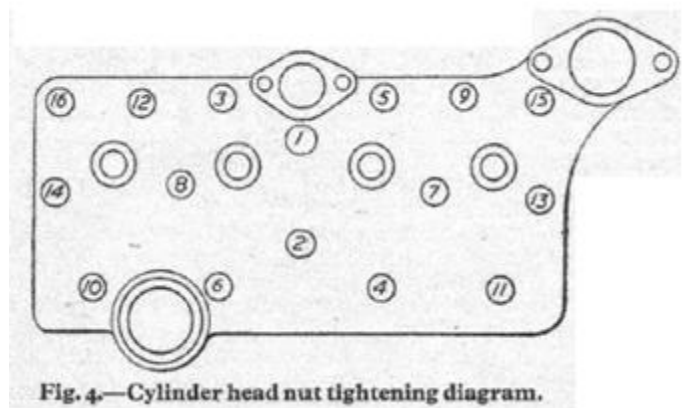
Fig. 4.—Cylinder head nut tightening diagram.

Tappet clearance is .015in. as checked by a feeler gauge. A type of wedge made of fiat plate can be used between a pair of tappet stems to prevent rotation while the locknuts are loosened and the adjustment made; this plate should be removed, however, when making the final check of clearance. Fig. 4 depicts the tightening sequence for the cylinder head nuts, which should be gone over several times to pull the head down gradually and evenly.

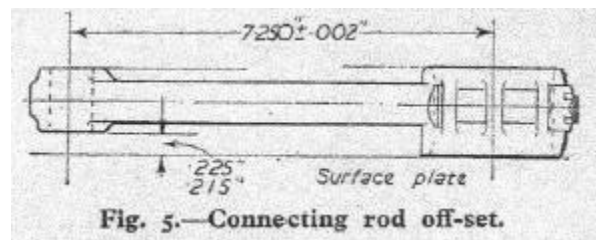
Connecting rods are offset (Fig. 5), and these and the markings should be noted for reassembly. The big-end caps must not be filed to adjust for wear since this would render the assembly non-standard. In any major overhaul it is recommended to check or have checked by a competent firm the alignment of the big-ends and small-ends. New clearances on big-end bearings are between .001in. and .002in., while side clearances lie between .008in. and .010in.

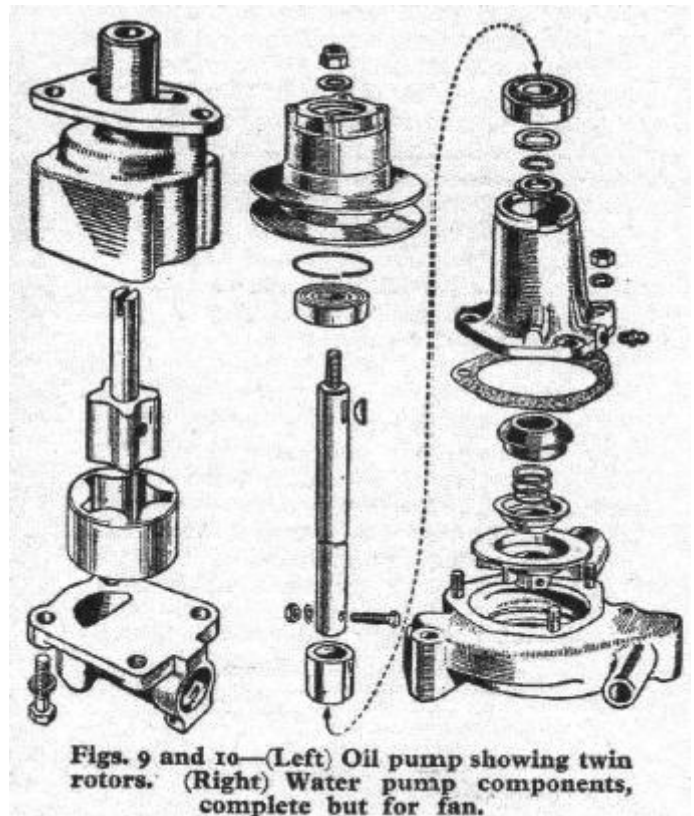
To dismantle the water pump (Fig. 10) the following is the procedure. The fan blades are removed, the nut and washer from the pump spindle, and the pulley withdrawn with a puller. The screw securing the rotor is removed and the rotor carefully levered off. The locating circlip for the bearing is removed and the spindle tapped out from the rear of the housing, complete with bearings, etc.

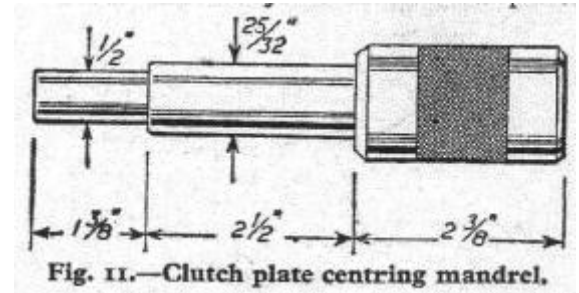
Fig. 11.—Clutch plate centring mandrel.

The clutch is a Borg and Beck type with a single centre plate and a graphite release bearing or thrust block. There should be clearance of $\frac{1}{16}$ in. at this point to ensure proper operation and approximately 1in. free movement on the clutch pedal. The release levers should move $\frac{1}{2}$ in. towards the flywheel in releasing the clutch and the stop should be adjusted to limit this movement. A centring mandrel is illustrated in Fig. 11 for use when assembling the driven plate.

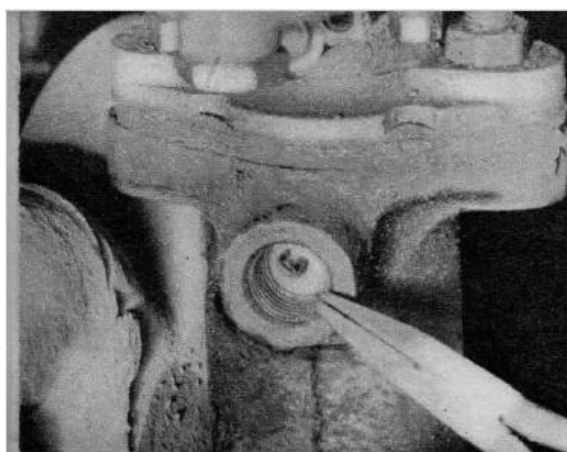
Removing the crankcase ventilation restrictor valve from the inlet manifold with pointed-nose pliers. Make sure there is no carbon on this valve or its seating

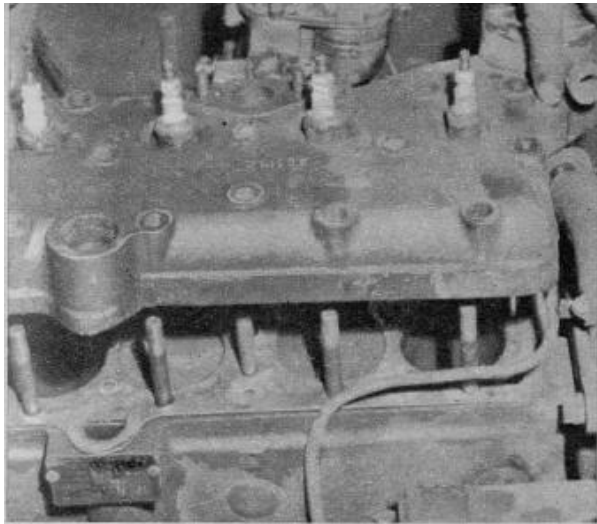
The light-alloy cylinder head should come off easily but if it sticks try soaking the studs with penetrating oil for 24 hours or using a specially designed cutting tool

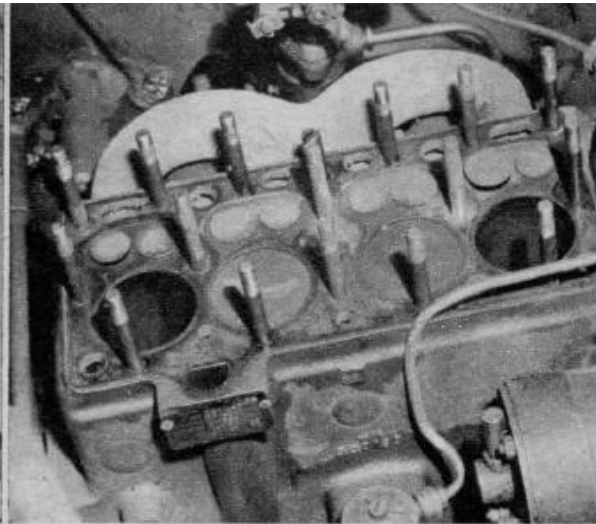
Here is the Mayflower engine with the head off. Don't scrape the piston crowns clean or oil consumption will rise. But the valves should be removed for a check

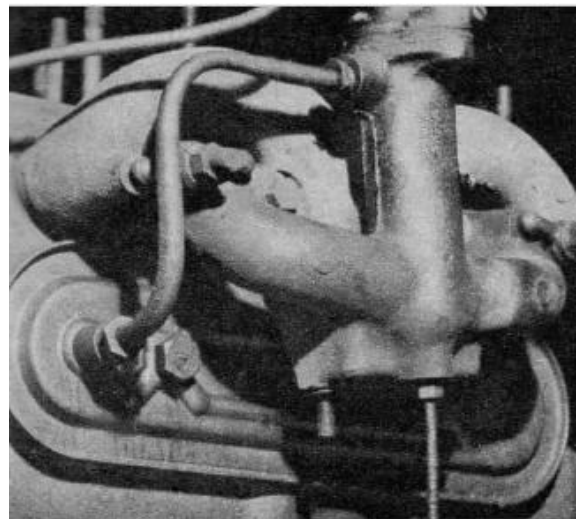
An often-overlooked item on the Mayflower engine is the manifold drain pipe coming from the base of the manifold. This must not be blocked or choked at all

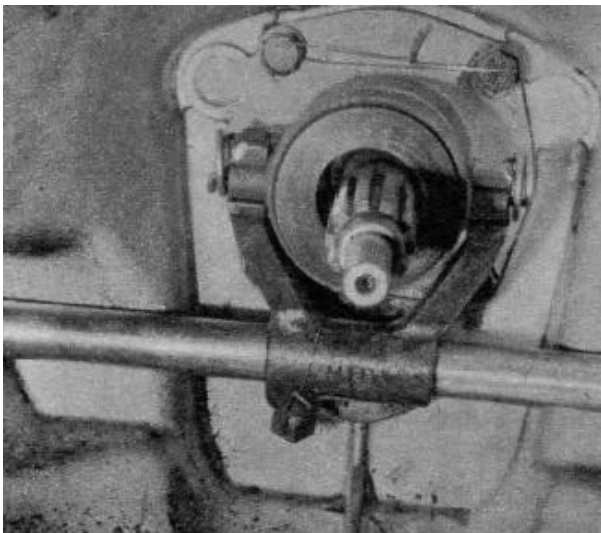
The effects of "riding" the clutch pedal can be seen in this picture of the carbon thrust which has moved sideways in relation to the pinion shaft in the centre

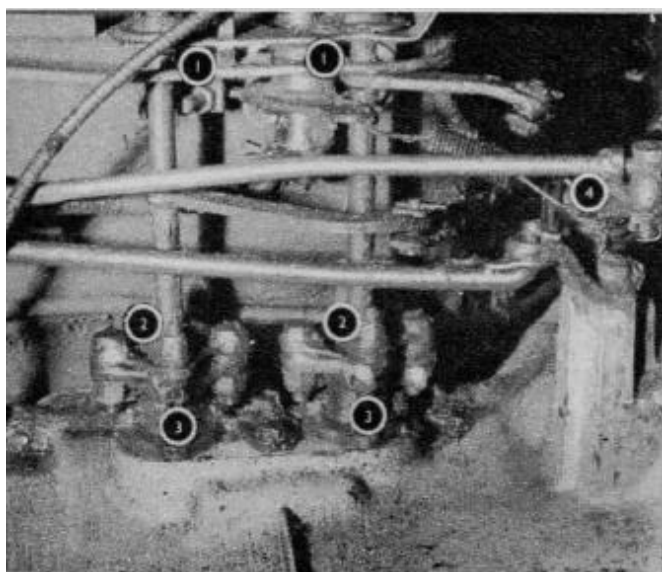
Wear-points on the gearbox. 1, the spherical bearing; 2, flexible transverse shaft couplings; 3, taper bolts on their trunnions and, 4, clutch adjustment point

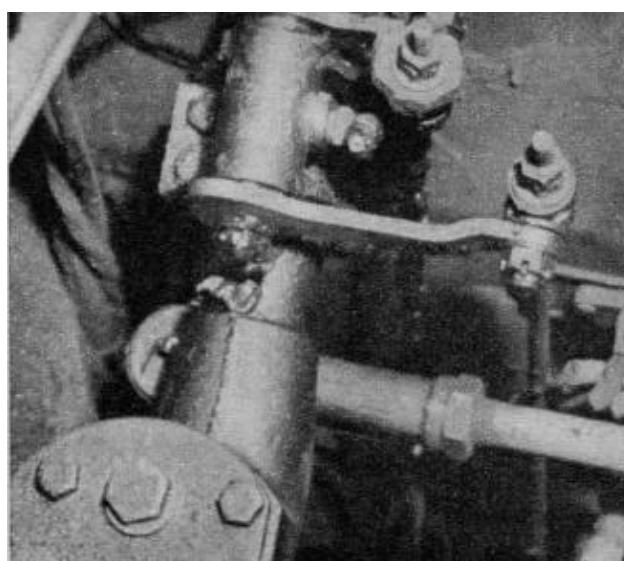
Close-up details of the gear-change adjustment on the steering column. Note the rubber bushes at the top of the rods—the one on the left is a D-I-Y product!

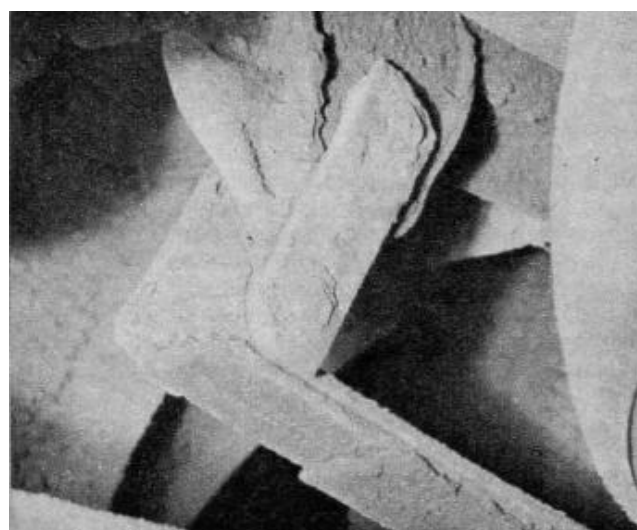
A mysterious noise can be caused after a large mileage by the rear-spring leaf hitting the hanger when the car is taking a corner at speed or heavily loaded
