THE
TRIUMPH
MAYFLOWER
CLUB

TECHNICALITIES: BODY, INTERIOR,
ACCESSORIES

February 2019 | Paul Burgess

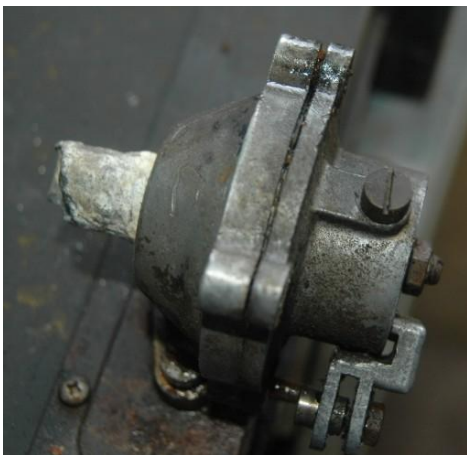
Here is the tap-

As you can see there is not much of the hose-connecting 'snout' left. Using some lock-jaw pliers, I managed to start the two cheese head screws, then undid them with a screwdriver. I could then separate the tap from the heater matrix.

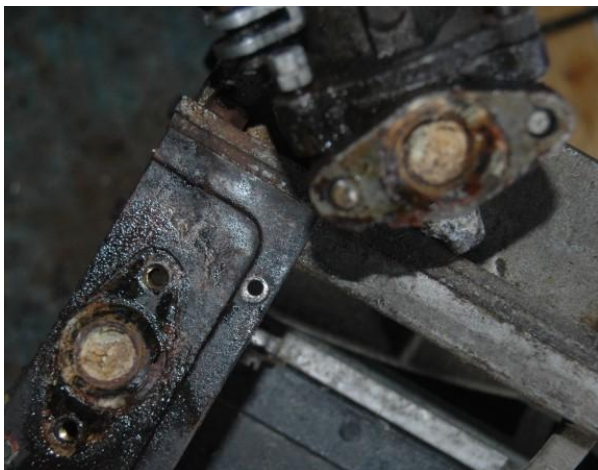
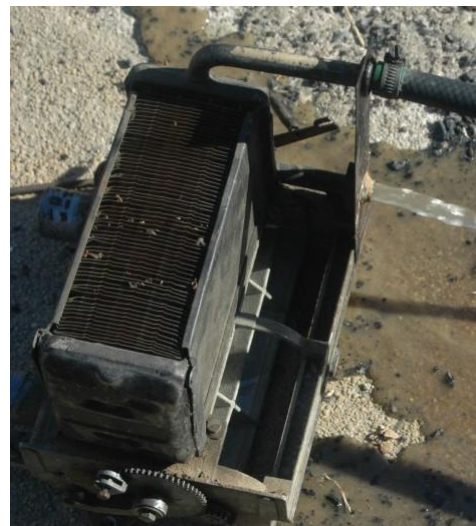
Both the tap and heater matrix were blocked. I managed to loosen the gunge that was in the matrix tube and then coupled it, via a hose, to the garden tap and flush the whole matrix through. I was pleased that there were no leaks to be seen.

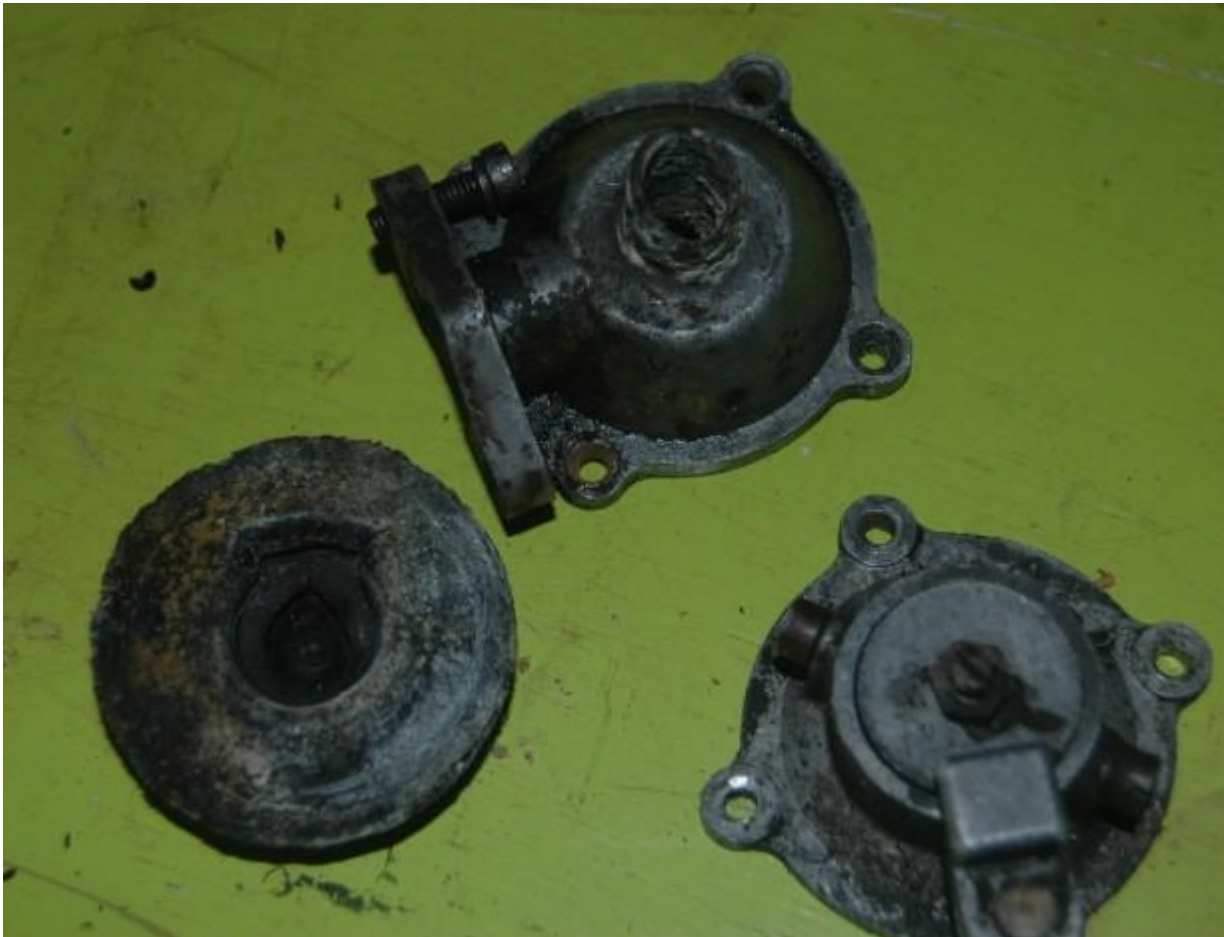
Now to tackle the tap proper. It is held together with four set screws with nuts, and after undoing those, I was able to prise the two halves apart. Apart from all of the gunge, there was a strangely distorted piece of rubber inside.

The question now arose, what did that rubber look like originally and where can I find another one?

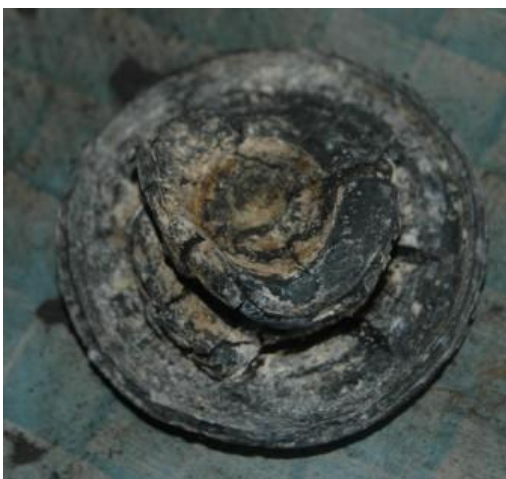
After cleaning the cavities inside the tap it became apparent that the screw and nut on the outside was an adjustment for the rubber diaphragm, and that a washer on the inside end of the screw should be embedded into that diaphragm. Now things started to become clear. The tap operates on a simple cam principle. As the outside lever moves, the cam causes the diaphragm to be pressed over the tap inlet to stop the flow, or alternatively to be withdrawn from it to allow the flow.

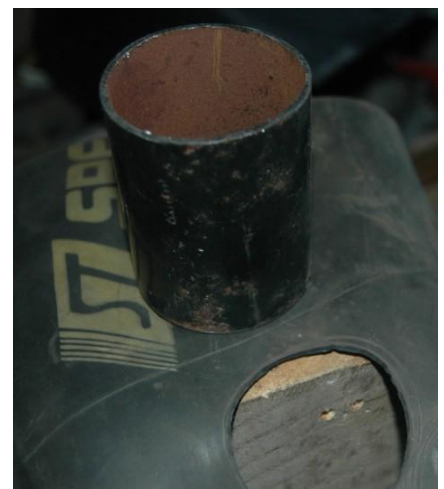
A car inner tube provided the rubber, but the large punch was less easy until I found a suitable sized piece of pipe- the internal diameter was the required one and seven eighths inches. Having sawn off a few inches of the pipe, I ground a cutting edge at one end, and proceeded to cut two rubber discs from the inner tube.

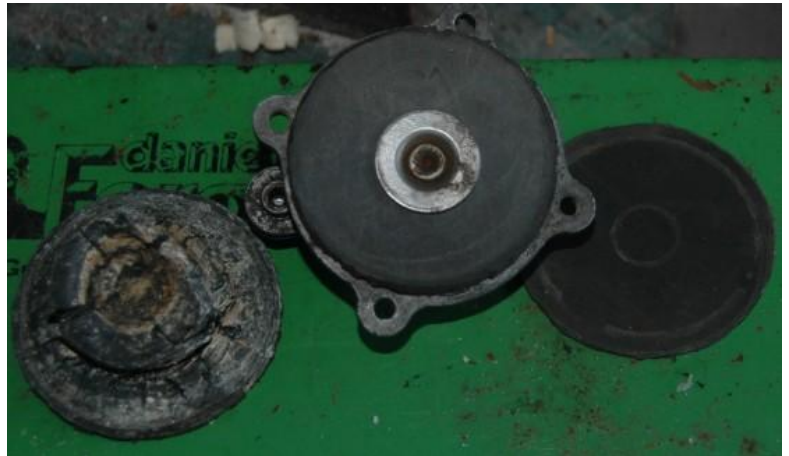
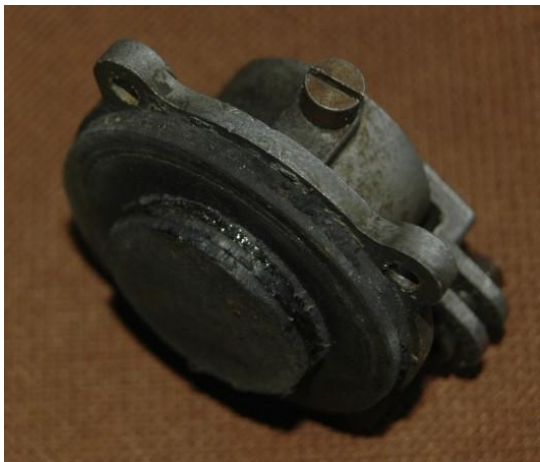
One of the discs had a small hole punched in the middle to allow the screw to pass through, but still retain the washer. The other disc was left whole. Then with the screw and washer in place, the two discs were glued together. Now I needed two smaller discs of about one and a quarter inches. These were cut and glued onto the assembly.

With that, the new diaphragm was test fitted into the tap half. After some testing and adjustment the two halves were reunited, and by blowing into the tap and moving the control rod I was fairly confident that the tap would work as intended.

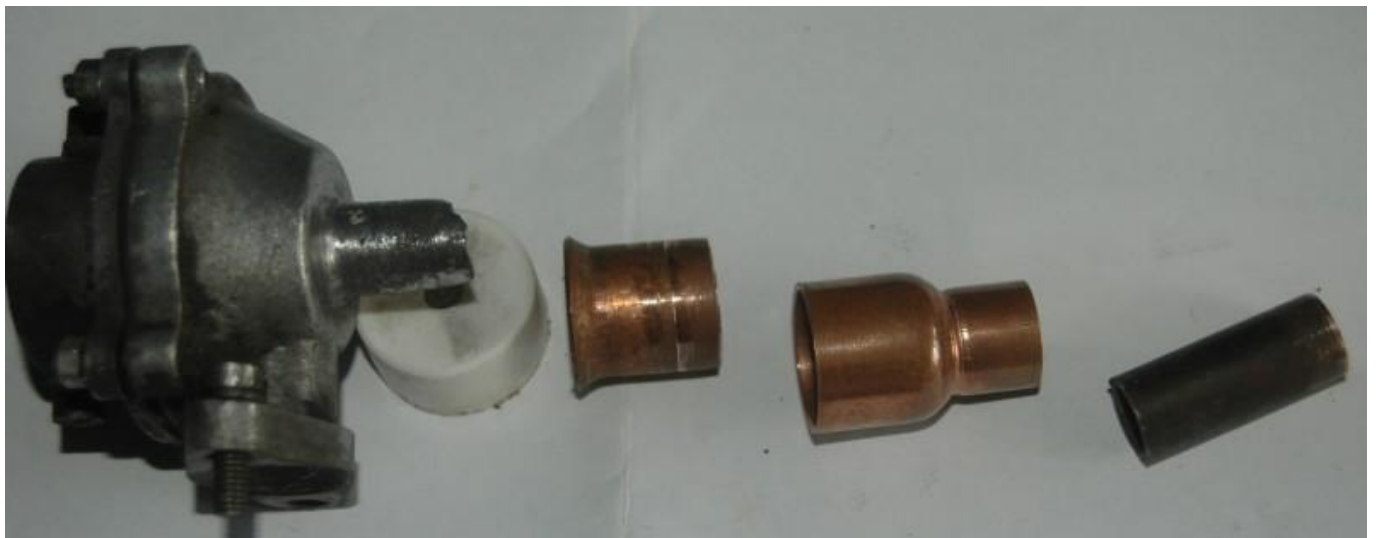
Now to make a suitable connection for the hose to the tap. Much wire brushing and scraping ensued to get rid of the corrosion on the tap's snout. Next I took a very short piece of 3/4" ordinary household copper pipe, and belled the end to give more surface area for the eventual joint. Next came a 3/4" to 1/2" inch reducer, and finally a short length of 1/2" copper pipe.

After cleaning the copper inside and out, I sweated them together with ordinary solder.

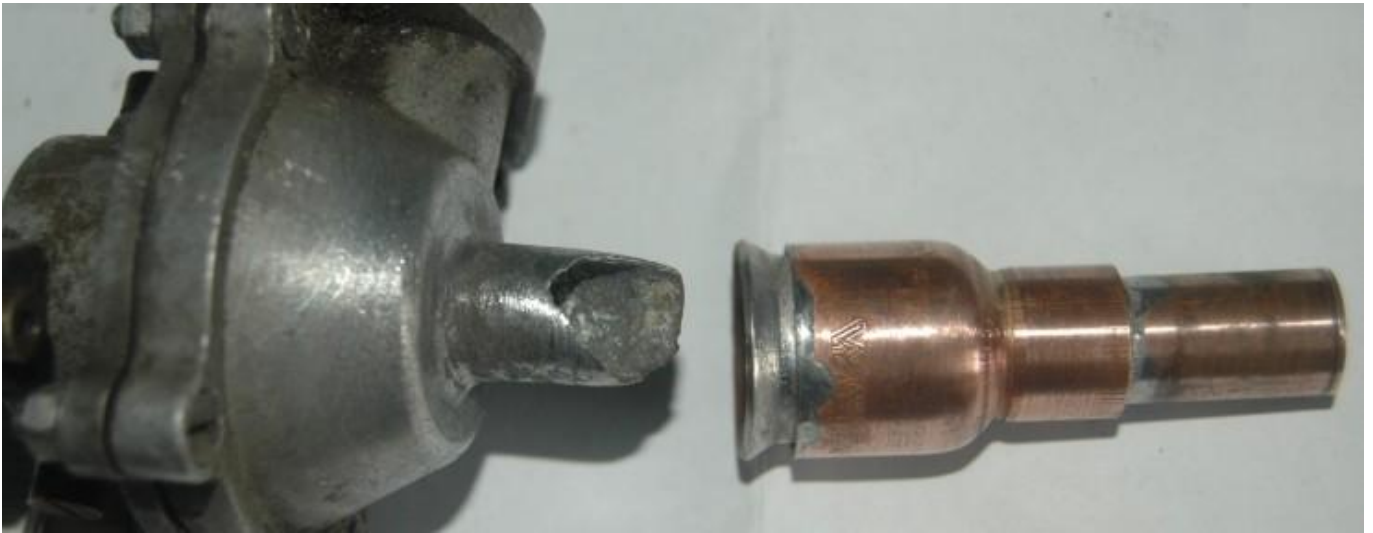
Next I used an American product that restorers there swear by. It is called J.B. weld and is an extremely strong, epoxy type material. This I used to coat the 'snout' and interior of the 3/4 end of the pipe assembly. J.B. Weld is a slow-curing formula so it was left for 24 hours.

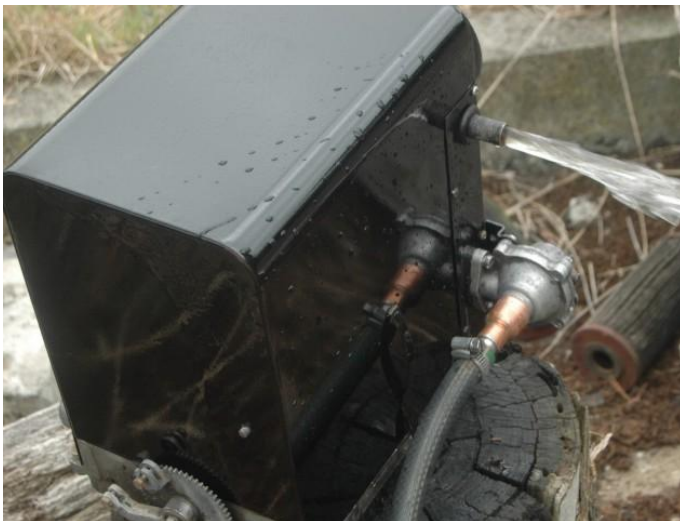
In the mean time, I worked on the main matrix assembly, cleaning the gears and freeing all moving parts. Now was the time to put the outer box case into place and test the whole thing for leaks and water flow. After that I wrestled the heater back into place on the car feeling rather pleased with the result.

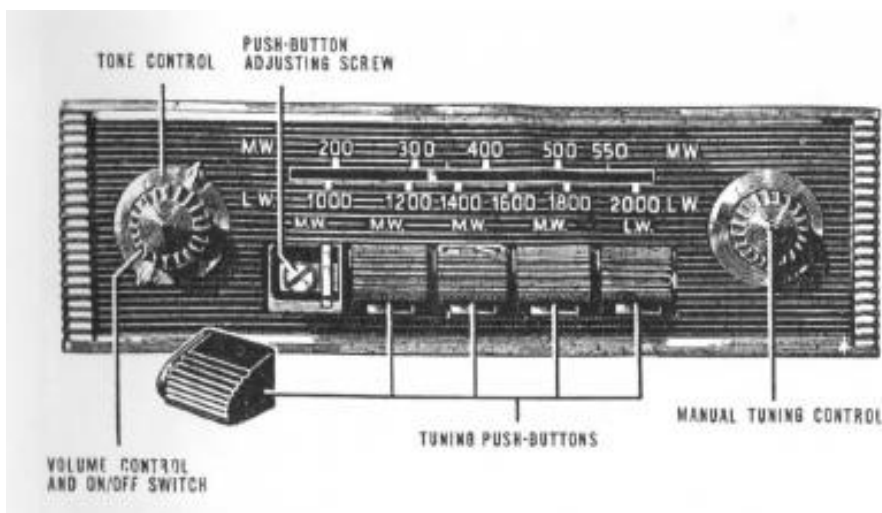
THE CONTROLS for these receivers are shown in the illustration above.

THE COMBINED VOLUME CONTROL AND ON/OFF SWITCH is on the left of the five push buttons. This control switches the receiver on when turned clockwise and progressive rotation of the control increases the volume. Turning the control fully anti-clockwise will switch off the receiver. Allow about 40 seconds for the receiver to warm-up' after switching on.

THE TONE CONTROL is concentric with the Volume Control and On/Off Switch and provides selective tone correction for reproduction of either speech or music, by four separate tone settings. The control is turned fully anti-clockwise for speech and fully clockwise for music, the two intermediate settings being provided to suit individual taste.

THE MANUAL TUNING CONTROL is on the right of the push buttons and provides completely variable station selection. A feature of this control is that the knob will not engage the tuning mechanism until it is pressed in; otherwise the knob will idle. This prevents accidental disturbance of a station setting previously selected by a push-button.

THE FIVE TUNING PUSH BUTTONS provide automatic tuning of five stations preselected from the Medium and Long wavebands. The right hand button provides for one station on the Long waveband, the four remaining buttons being employed for Medium Wave pre-selection. The indication MW (Medium Wave) or LW (Long Wave) is marked on the Tuning Scale immediately above each pushbutton. Wave-change switching is automatically effected when a button is pressed for any pre-selected station.

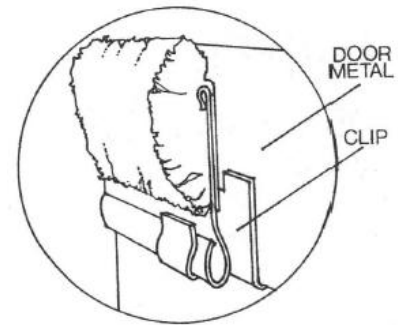
STEP 11

Press home weather strip into spring dip.

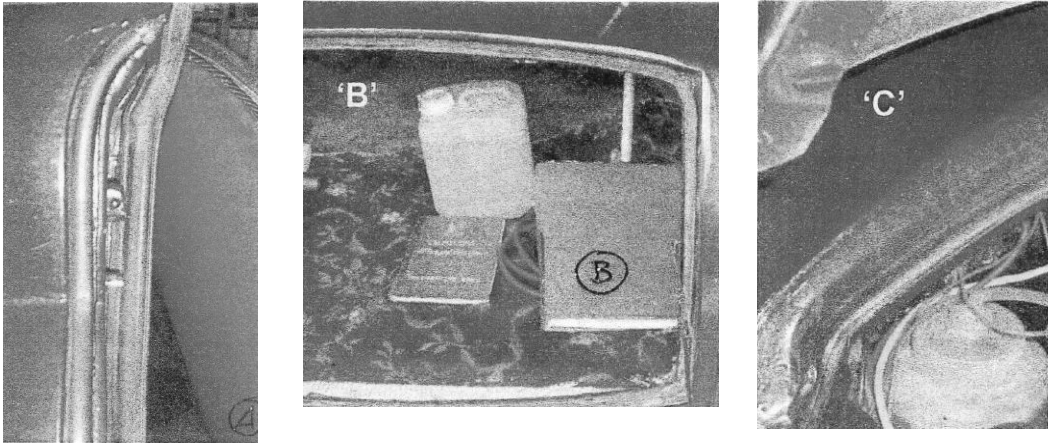
My trade before being made redundant was a domestic appliance engineer. One of the appliances I repaired were washing machines. I found the back plate gasket for a Hotpoint WM63 fitted the door slam (picture A).

The boot seal was made up of the Hoover Matchbox back plate gasket using three gaskets shown in the picture B. The bonnet seal nearest the windscreen was also a back plate seal from a Bendix 7142 A, Picture C.

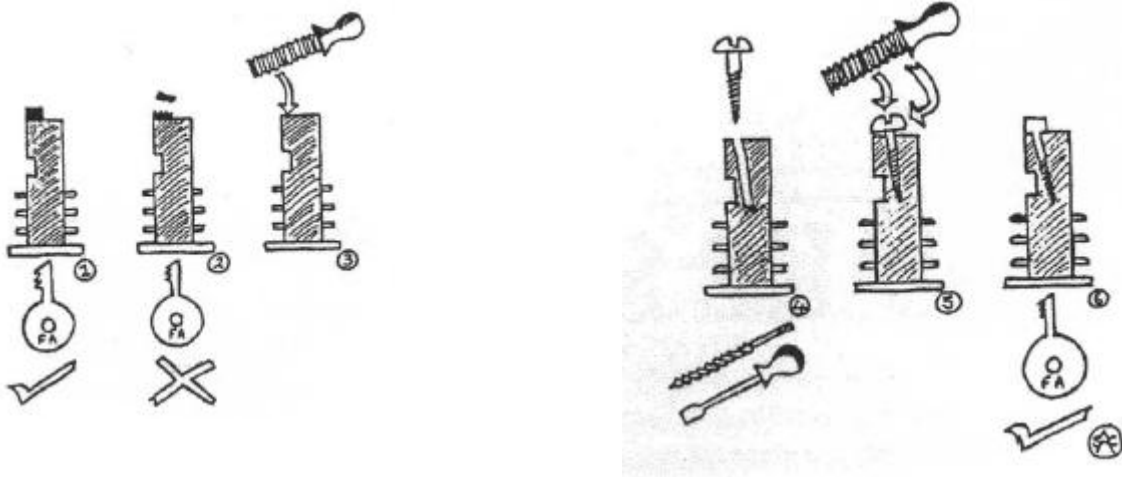
1. When new the barrel has a nib on the end that acts as a cam to engage the lock. Nothing fancy or complicated.
2. Due to abuse or fair wear and tear the nibs break off or wear down so that the lock becomes inoperative.
3. With a soft file gently remove the remainder of the nib leaving the end of the barrel flush.
4. Drill a pilot hole at an angle into the barrel starting from where the nib has been removed. Gently insert a suitably sized self-tapping screw.
5. File off the head of the screw to dimensions similar to the original. There is a certain amount of guesswork here but I got it right on both occasions (clever old me).
6. Refit the barrel and lock up your Mayflower.

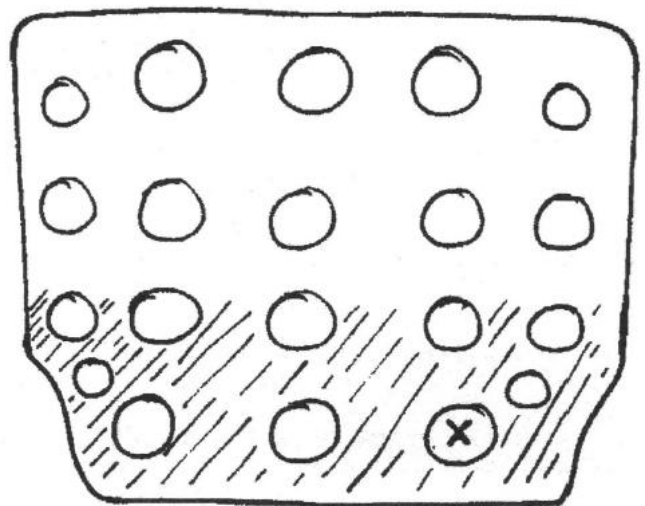
Fig. 1 — Rear of seat

If you are going to recover the seats the spring can be replaced, however, if the seats are in good condition replacing the spring is not easy but you can affect a temporary repair. Strap a three inch piece of spring steel to the existing broken section and bind with heavy gauge wire, and then solder the binding wire.

This works surprisingly well and to boost the filling in the shaded area a double fold of ordinary household carpet manoeuvred into position will level it out. This will at least help until you are ready to repair and recover the seat.

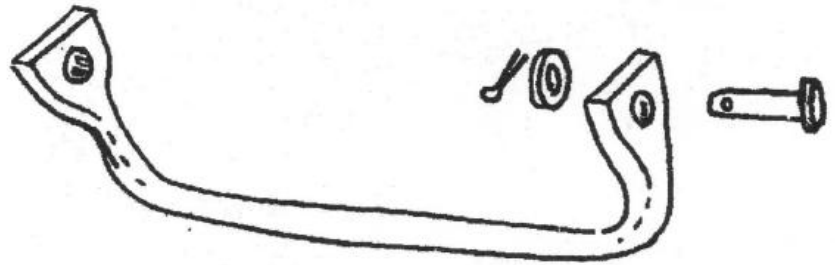
Fig. 2 — Front swivel bar showing the method of attachment

The next problem concerns the front swivel bar. It is attached to the seat frame by two steel dowels secured by split pins. The problem is that the split pins break off leaving the dowel to move out of position. Seat movement is incorrect and also causes the rake of the back rest to move further back than normal. In addition it can allow the side of the back rest to hit the door armrest when moved forward, causing wearing of the fabric on the back rest.

When refitting the dowels ensure that a washer is between the frame and split pin (see fig. 2).

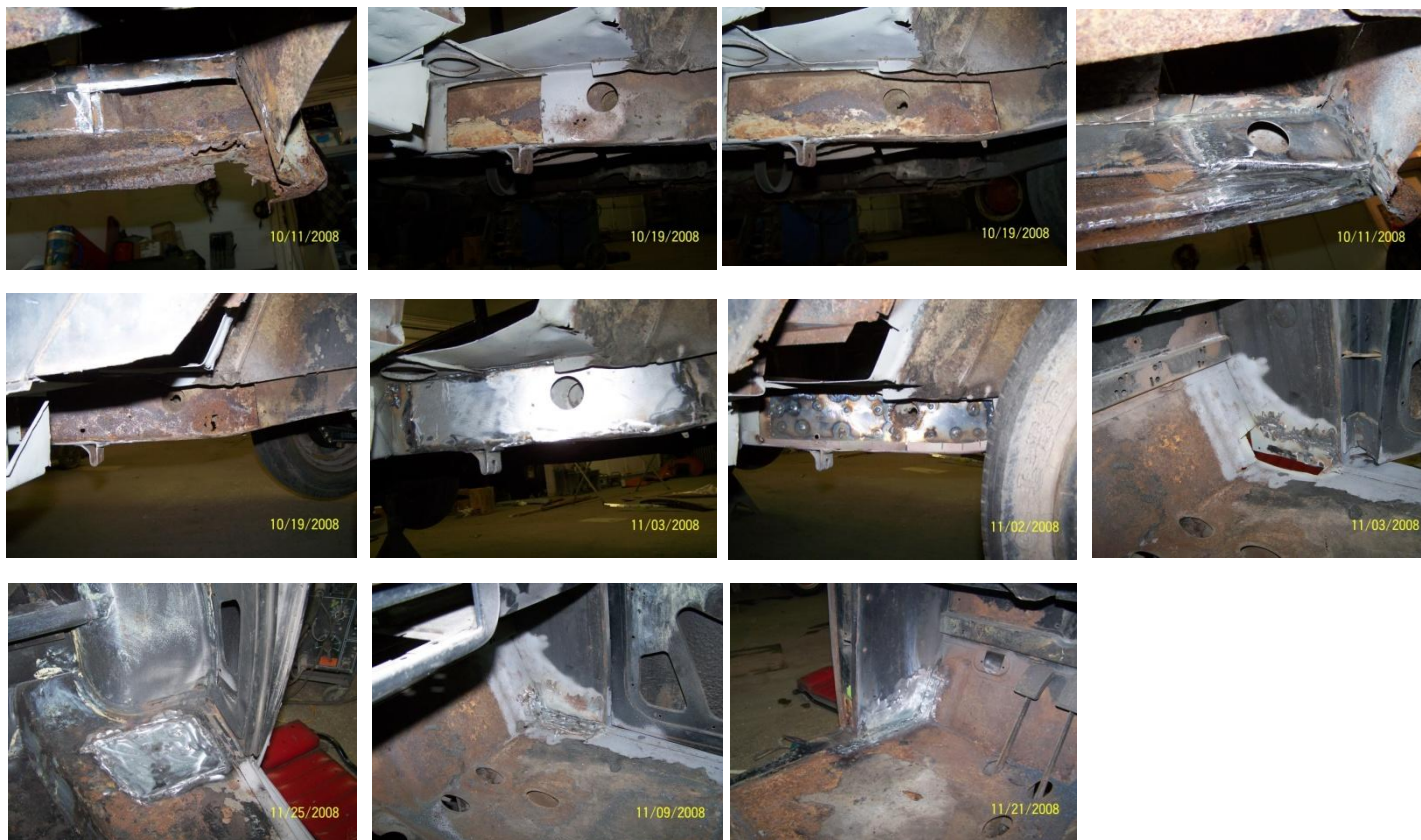
Inside Corners, frame and floors:

Start the repair from the inside and work outward, so first are the inner corners. Once they are done and the floor and frame are completely solid, come the outriggers.

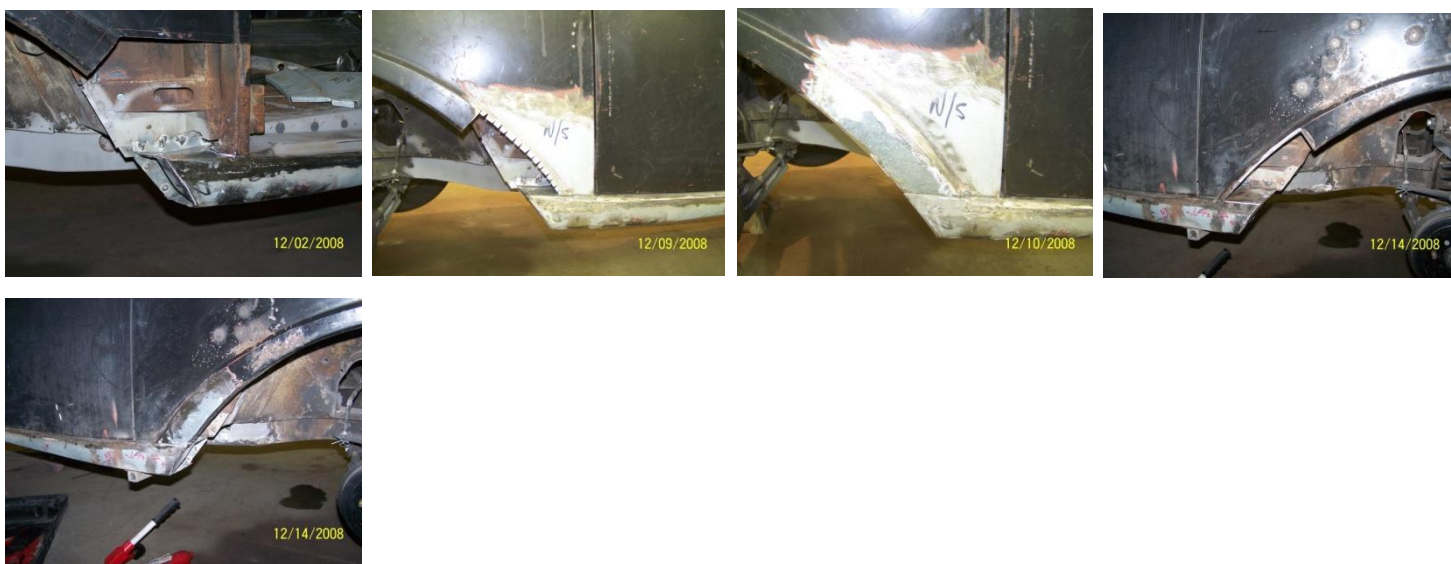
Front fender patches:

What was found with the front fender patch panels, the raised arch was so wide that the panel could have fit the original contour below the sill. Photos show this. The fender patches were altered and used, the inner sills were used with no issue. The outer sills were used by sectioning both to achieve the correct height. Then you have to use care in positioning them to achieve a proper and good-looking bottom door gap. This was done prior to welding the top and lower portion of the sectioned sill together. The too tall outriggers were cut up and the metal used as patches (they did not have the original reinforcing “X”. The sill caps were not used. On the good side, all of these panels showed us how they were formed and functioned. We would have never thought to add the drainage “V” creases into the lower sills without these panels.

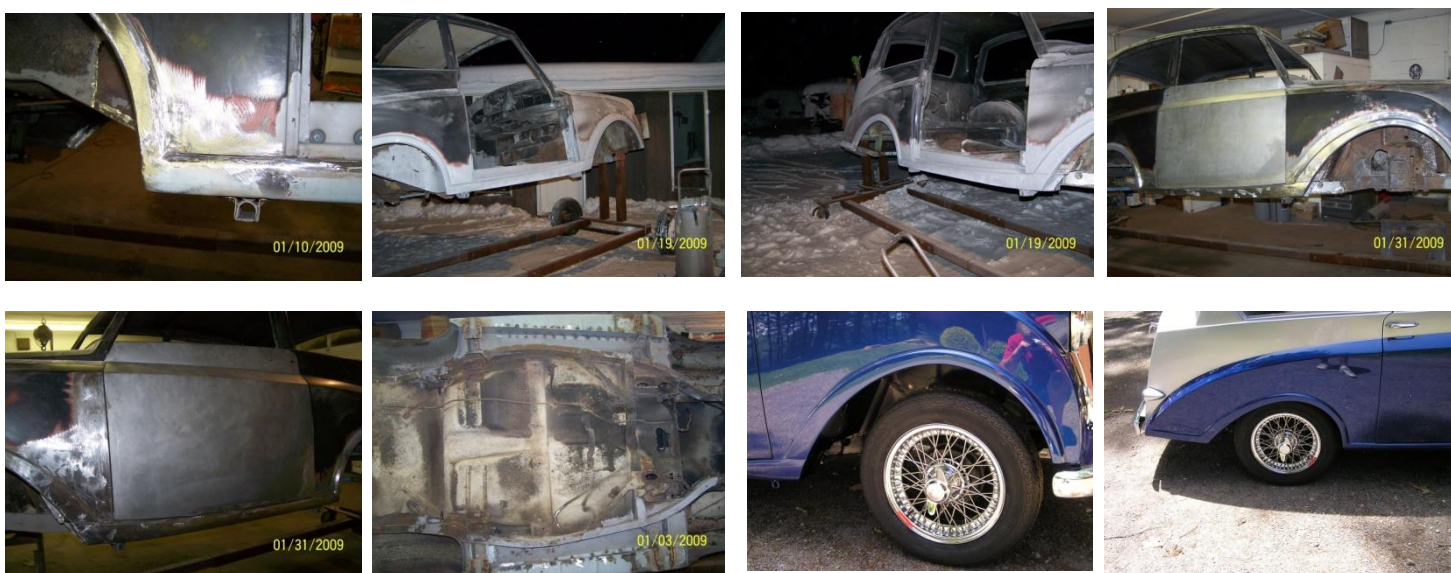
Finished:

The end result is an extremely strong body unit that should last another 50+ years easily.

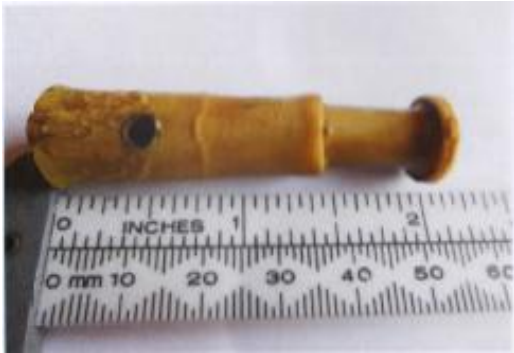
Beginning with the starter control, in point of fact the easiest to remove, I soon discovered a hole at the base of that knob containing what appeared to be a fixing pin. One mirror and a stiff neck later I'd satisfied myself that all the knobs, plus the ignition/lights controls, were secured in the same manner.

Now with the old starter knob held in a vice I managed to tap this pin in using a small metal drift and then succeeded in pulling the cable free. As you can see what I discovered was a six sided metal insert which remained fixed to the plastic knob thanks to a tiny metal leaf spring.

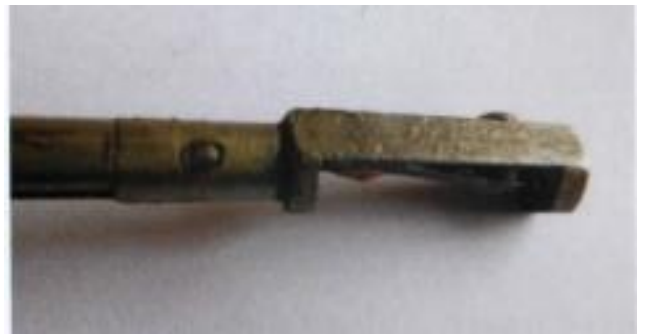
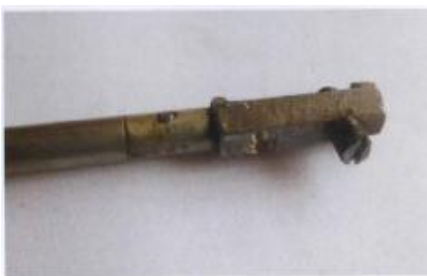
Alas over time the spring had simply rusted to dust so another method of fixing would have to be employed. It then occurred to me that the now redundant pin was very close in size to some 4m machine bolts I happened to have in stock.

So after carefully drilling out the hole in the plastic so one of these would slide in and out freely I cut a 4m thread into the metal insert. As an unobtrusive fixing was required I simply cut the head from each bolt, carefully added a screwdriver slot with a hacksaw and turned them into grub screws.

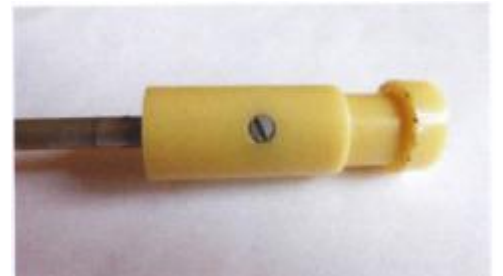
As you may judge the result appears quite professional with the added bonus that as screws secure the controls future removal should be an easy task.

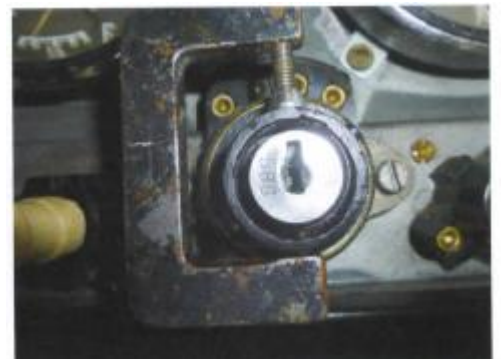
The ignition/light switch still used the same loaded pin arrangement to retain its plastic surround but here a more robust circular spring was employed.

This I found still viable so using a small "G" clamp and copious amounts of WD40 I worked the pin in and out until I was able to slip the new cover in place.

As I said before, the heater control just screws into place. After that it's simply a case of cleaning everything up and reassembling.

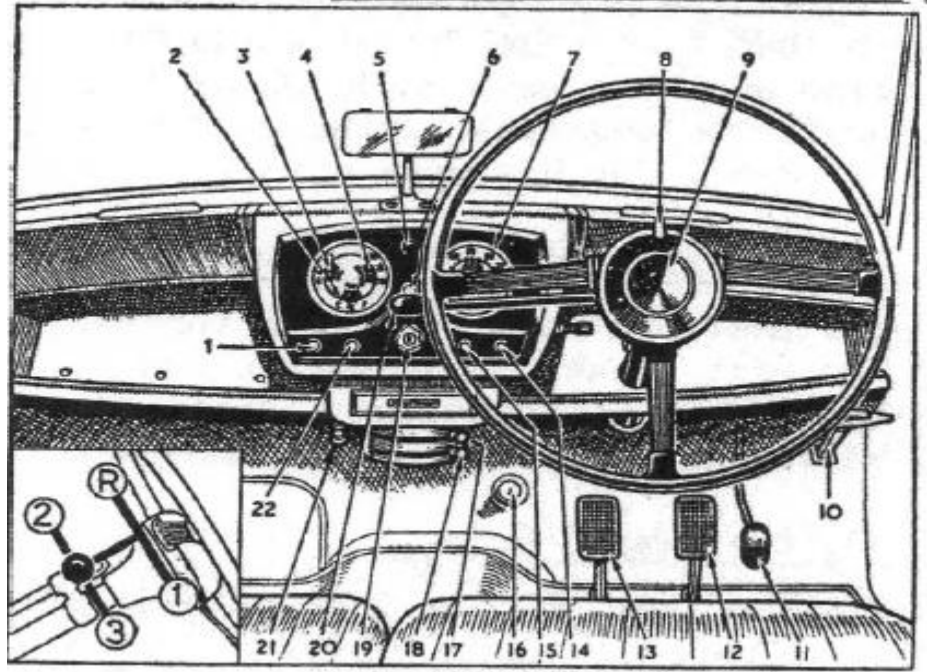
1. Choke
2. Petrol gauge
3. Oil pressure gauge
4. Water temperature gauge
5. Ignition warning light
6. Heater motor switch
7. Speedometer
8. Trafficator switch
9. Horn push
10. Handbrake
11. Accelerator
12. Brake pedal
13. Clutch pedal
14. Starter switch
15. Screenwiper switch
16. Dipper switch
17. Heater air control
18. Demister control
19. Lighting and ignition switch
20. Gear lever
21. Scuttle ventilator control
22. Panel and roof lamp switch
